IDENTIFICATION OF SLIP SURFACE USING 2D RESISTIVITY METHOD, CASE STUDY IN PIDADA, BANDAR LAMPUNG

Abstract: Landslide is a disaster that occurs influenced by morphology, lithology, geological structure, hydrogeology and land use factors. Pidada Urban Village, Panjang District, Bandar Lampung is an area with morphological conditions in the form of hills with steep slopes. Based on data from the Center for Volcanology and Disaster Mitigation (PVMBG) in January-October 2019, the research area in Panjang District has the potential for medium-high mass movement. Criteria for the occurrence of landslides are steep slopes, the presence of slip surface below the surface of water saturated soil and the amount of water content that comes from rain water that seeps into the ground. One of the geophysical methods that can detect skid fields is the 2D Resistivity Method of Wenner-Schlumberger Configuration. Through this method it is known that areas that have high water content are indicated by low resistivity values. In this study, measurements were carried out on the slip area in a landslide prone area. After measuring the 2 lines, depth of the slip area of the study area was obtained.

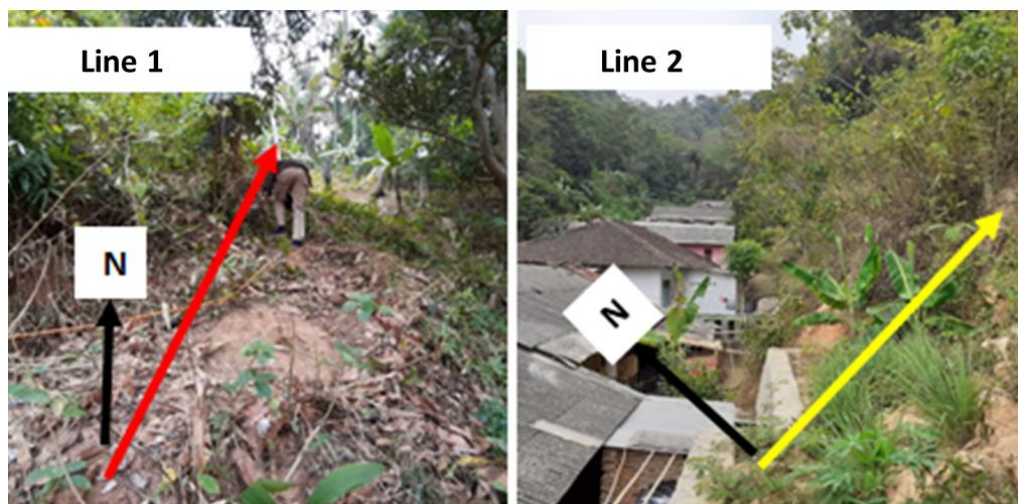
Figure 2. Visualization of the Research area.

Data collection in the study area was carried out on 2 lines using the Wenner-Schlumberger configuration with a length of 115 meters each. The first line with the transverse direction to the northeast. Point 0 measurement is located at coordinates E 535851 and N 9395722 with an elevation of 23 meters above sea level and an end point that is with a stretch 115 m located at coordinates E 535908 and N 9395820 with an elevation 64 meters above sea level. The second line with the transverse direction to the northeast. Point of measurement 0 is located at coordinates E 535873 and N 9395690 with elevation of 19 masl and the end point of 115 m is located at coordinates E 535987 and N 9395693 with elevation of 55 masl. The measurement map is presented in Figure 1 and the visualization of the research area is presented in Figure 2.

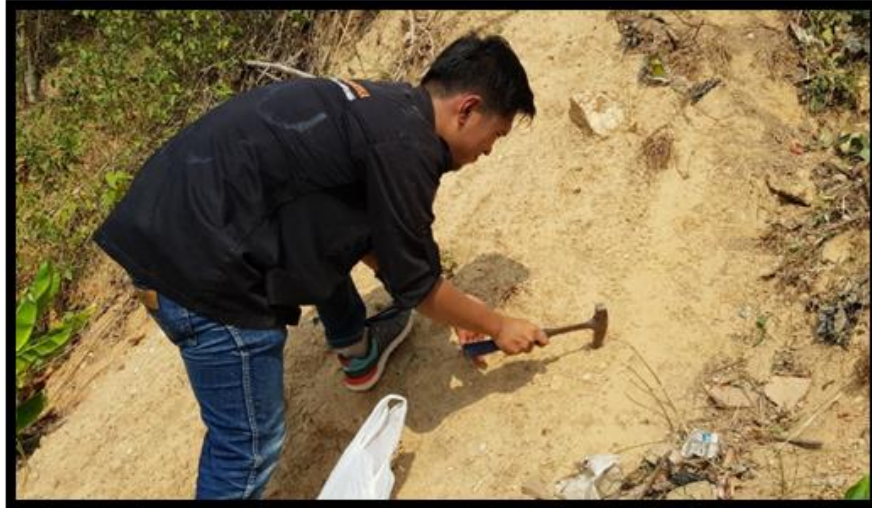
Figure 5. Location of landslide on line 2.

Line 2 generally has the same characteristics of subsurface medium as Line 1. Layer of the slip surface is obtained between the contrast value of resistivity between two mediums which are close together. It is imaged with a black dotted line which is an area suspected as a layer of weathered rock or vulnerable zones imaged by a red dotted line in the form of a layer of sediment tuff and sand sand which can be a zone saturated by water, in this path 1 there is 3 water saturated zones at a length of 12, and 45 m with a depth of 5 and 6 m respectively. If high rainfall allows water to accumulate in these layers, thus causing these layers have movement. In this second line, the prone zone area is located right next to the settlement or is at the bottom of lane 1 and at the bottom of cross section 1 has a slope of $> 30^\circ$ which makes this area a prone to landslide disaster, as evidenced by the occurrence of landslides in

February which caused a destroyed house. The location of the landslide or ground movement is presented in Figure 5.
