Your manuscript entitled: "**Potential Hazard Analysis And Mechanism Of Landslide And Debris Flow In Semaka, Tanggamus** " has been peer-reviewed and accepted, Congratulations! Please be advised that your manuscript is recommended for publication in (**International Conference Proceedings (AIP) - Indexed Scopus**). For further information, please visit our official website at <https://ulicoste.unila.ac.id/>.

# Potential hazard analysis and mechanism of landslide and debris flow in Semaka, Tanggamus

**Abstract.** According to the Tanggamus Regional Disaster Management Agency, debris flow and landslides floods occurred three times throughout 2020 in Semaka, namely on January 10, August 5, and September 30, 2020. This landslide and debris flow destroy 483 houses and at least 300 hectares of farm fields. The phenomenon of debris flow was a recurring event because the efforts to reduce disaster risk have not been optimal. This study aims to provide data/information on field surveys, hydrological analysis, geotechnical investigation, and mitigation techniques to reduce the disaster risk. This research begins with a preliminary investigation, field survey, and data collection. The study

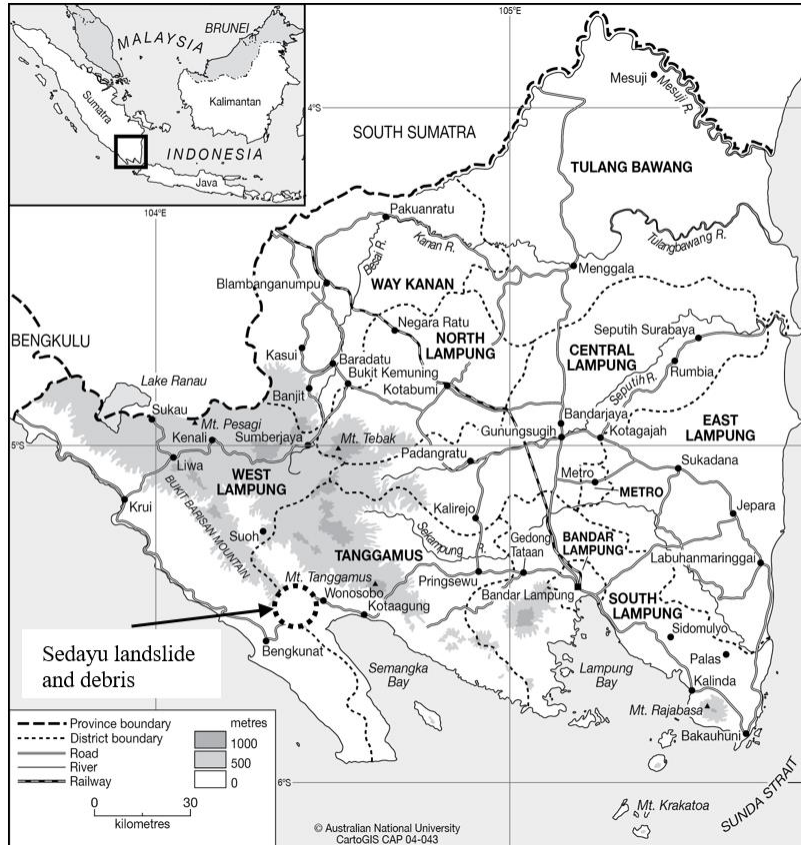
This paper presents the result of site investigation at Pekon Sedayu and Pekon Waykerap, Tanggamus Regency, Lampung Province (Figure 1). The Landslides is located in the bottleneck and close to the alluvial fan. This landslide has 55 m to 90 m of height and is located at coordinates 5°30' of south latitude and 104°28' of east longitude. The landslide material hit residents' housing and the road to Bengkulu. A potential landslide can be observed near the river.

**FIGURE 1.** Study site at Pekon Sedayu, Semaka District, Tanggamus Regency, Lampung

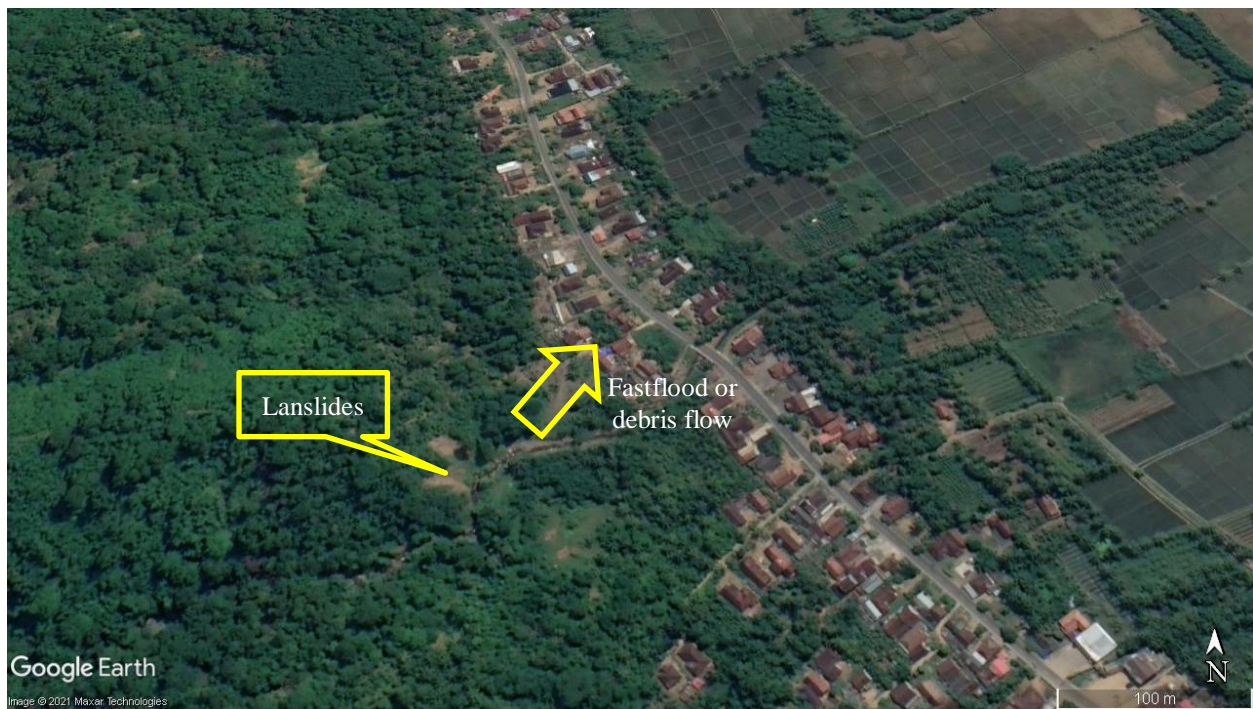
**FIGURE 2.** Landslide and fastflood in Sedayu, Semaka Distric, Tanggamus Regency, Lampung

In this study, potential landslides were identified as a source area. Affected areas of the landslide were estimated based on incident data on January 10, August 5, and September 30, 2020. Based on field investigation results, potential landslides have been found on the slopes along with the river flow. Landslide materials move to the river and transform into flash floods or debris flows (Figure 1). Based on testimonies from residents living in the affected area, the landslide followed by flooding occurred at night around 20.00 WIB, preceded by heavy rain from the afternoon. In the past, flash floods also took place in the same flow path and affected areas.

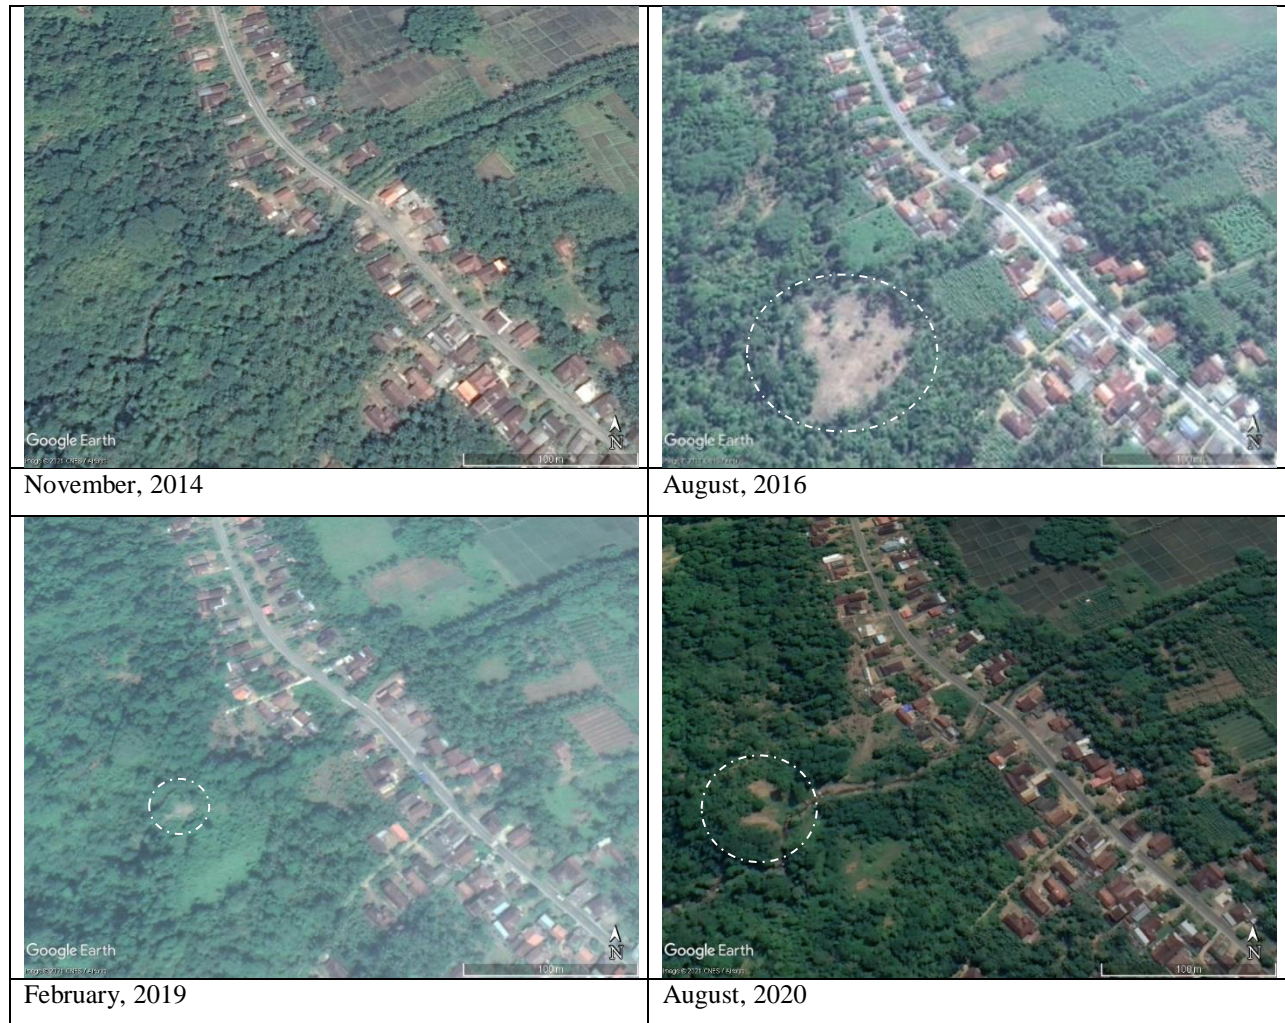
**FIGURE 4.** Geomorphology before and after landslide

Morphology before the landslide was obtained from Google Earth satellite data and DEMNAS imagery data with a resolution size of 8 m. land use in the area around landslides and floods did not change significantly. In November 2014, the upstream of the river was still dense vegetation. The flow path was visible, and no landslides or erosion along the river bank (Figure 4). In August 2016, the slope of the right side of the river channel was exposed for 100 m. The landslide material moves to the river channel. In February 2019, the landslide occurred on the left side of the river bank and seemed to be getting bigger in August 2020. The landslide material moves to the river and can transform into a debris flow or flash floods.

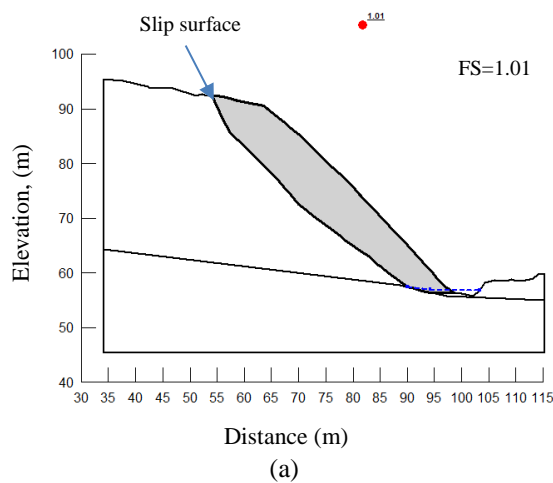
1 $c=0 \text{ kN/m}^2$ ; $\phi=34.68^\circ$	6 $c=21 \text{ kN/m}^2$ ; $\phi=24.78^\circ$
2 $c=10 \text{ kN/m}^2$ ; $\phi=30.21^\circ$	7 $c=22 \text{ kN/m}^2$ ; $\phi=24.26^\circ$
3 $c=15 \text{ kN/m}^2$ ; $\phi=27.81^\circ$	8 $c=22 \text{ kN/m}^2$ ; $\phi=22.68^\circ$
4 $c=19 \text{ kN/m}^2$ ; $\phi=25.81^\circ$	9 $c=25 \text{ kN/m}^2$ ; $\phi=19.96^\circ$
5 $c=20 \text{ kN/m}^2$ ; $\phi=25.30^\circ$	10 $c=30 \text{ kN/m}^2$ ; $\phi=17.13^\circ$

**FIGURE 7.** Back analysis with limit equilibrium method

The result of slope stability analysis using the limit equilibrium method in the actual condition during collapse is shown in Figure 7a. Slip surface is simulated similar to that occurs in the field based on the field surveys and mapping. The values of  $c$  and  $\phi$  were tried to result from the same slope model with field conditions. The relationship between the values of  $c$  and  $\tan \phi$  is linear as shown in Figure 7b. The value of the internal friction ( $\phi$ ) and cohesion ( $c$ ) which results in the value of  $FS=1$  is number 5 in Figure 7c. The results of the analysis show that the value of the soil shear strength parameter for the slope is  $c=20 \text{ kN/m}^2$ ;  $\phi=24.78^\circ$ . The soil shear strength parameter as a result of the back analysis is still in the range of laboratory test results.

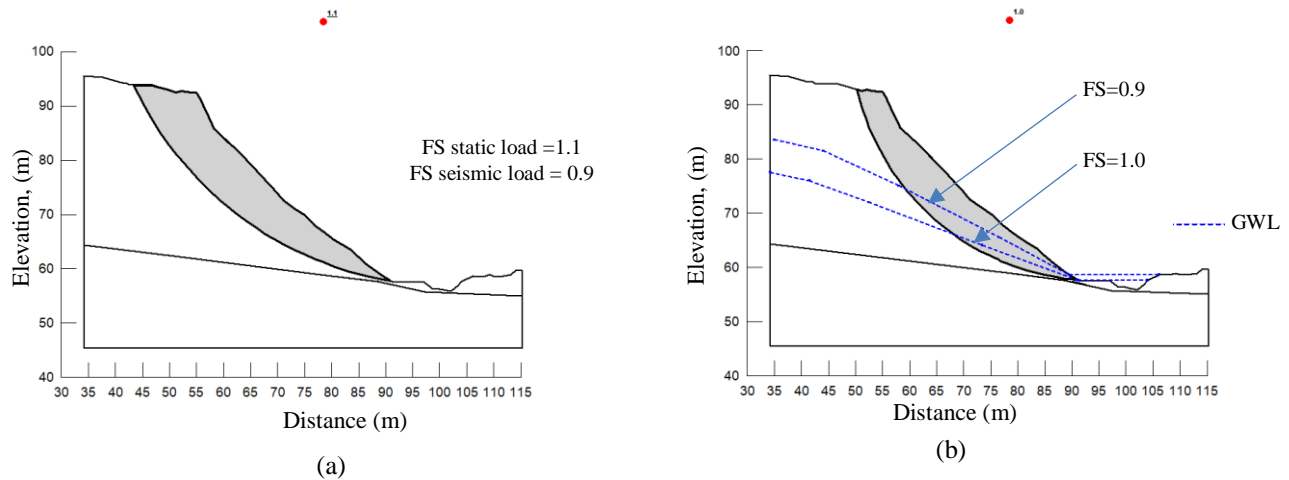
**FIGURE 8.** earthquake or groundwater induced slope failure

The result of modeling on the actual condition shows that the value of SF without any increase in groundwater level is 1.1. It means that the slope has not yet collapsed, even though it is in a critical condition. If there is an increase in seismic load, for example, an earthquake the slope becomes unstable with a safety factor value of 0.9 (Figure 8a). High intensity or long-duration rainfall can cause groundwater level rise. High intensity or prolonged rainfall can cause groundwater levels to rise and slopes to become unstable or collapse. SF decreased from 1.1 to 1.0 and 0.9 due to the increase in groundwater level as shown in Figure 8b.

Landslide materials move to the river and can transform into flash floods or debris flows. With a channel width that is not too large, landslide material can block the flow path. This event resulted in the occurrence of a natural dam, if it collapses it can transform into a flash flood. Landslides and floods that occurred in the past caused the Kota Agung-Bengkulu road's broken and inundate residents' houses as high as 1-1.5 m. Therefore, structural mitigation in the form of slope protection, reinforcement and drainage improvement on unstable slopes needs to be done to reduce the risk of disasters caused
