The Evolution of Concrete (Part 2): Unprotected in Humid Tropical Weather and Its Compression Strength

Abstract

This research was conducted with a case study on the Basement Floor of the State University Hospital (RSPTN) of the University of Lampung in Lampung Province, Indonesia. This building has been neglected for 10 years. Part of this basement floor is protected and partly unprotected (Figure 1).

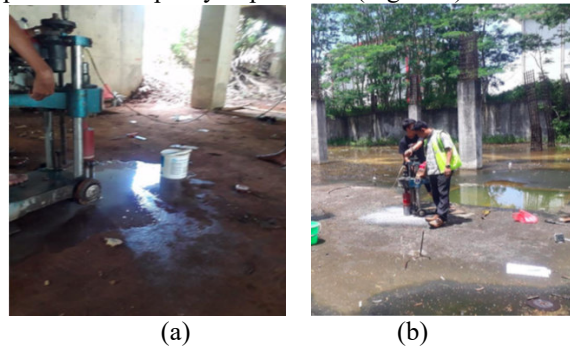
Figure 1. Basement condition: (a) protected, (b) unprotected

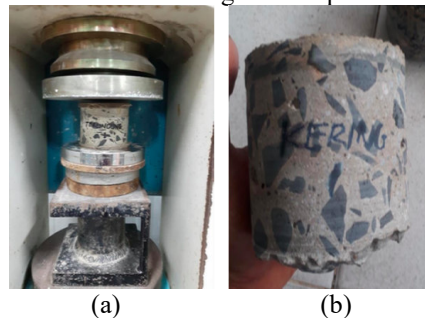
Each condition was sampled using 4 core drills for testing the compressive strength (Figure 2).

Figure 2. Drill core samples: (a) shielded, (b) unshielded

Splinters in the drill core were also taken for Scanning Electron Microscopy (SEM) and Energy-dispersive X-ray spectroscopy (EDX) tests.

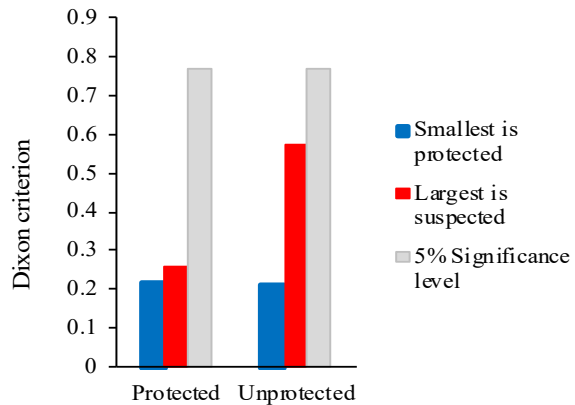
Figure 3. Examination of data

Compressive strength data is processed by outlining method. From this processing, the largest and smallest data values for protected and unprotected concrete are below the 5% significance level. Thus; all data can be accepted (Figure 3) and compressive strength can be calculated from the average data (Figure 4).

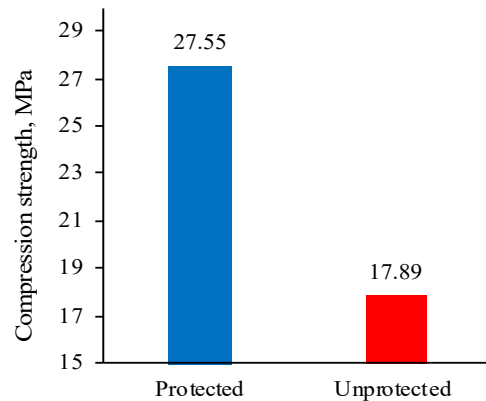
Figure 4. Compressive strength of concrete

The presence of an element that triggers oxidation and the presence of water makes unprotected concrete more fragile. The strength of the concrete decreases to 65% of the compressive strength of the protected concrete or 17.89 MPa while in the protected condition it is 27.55 MPa.

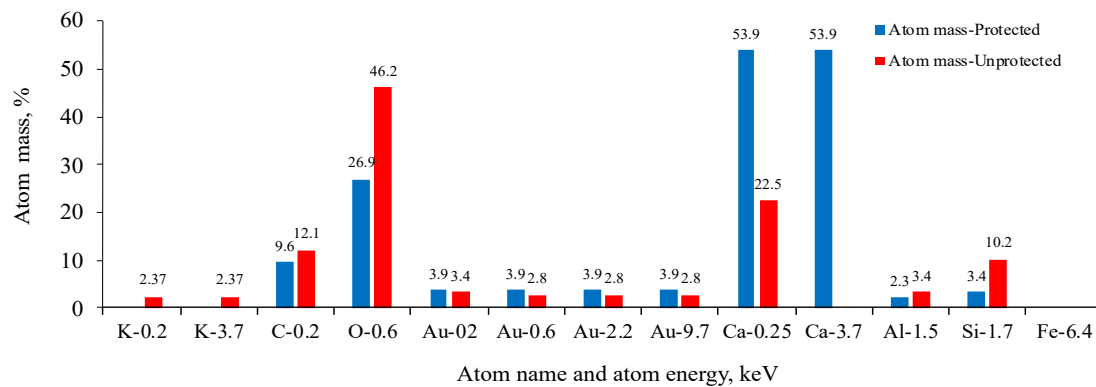
The relationship between energy, dynamic viscosity, and atomic mass is presented in Figure 5.

Figure 5a. EDX: atom mass, and atom energy of protected, and unprotected concrete

Kalium or potassium is the only element present in unprotected concrete but not in protected concrete (Figure 5a). Potassium shows a dynamic viscosity that is almost the same as other elements found in protected and unprotected concrete.

In the protected condition, the concrete compressive strength mainly comes from the contribution of C-S-H and CH. Elements of Ca and Si play a major role in the quality of concrete. The atomic mass of Ca in the protected condition is 2.4 times the unshielded condition, but the atomic mass of Si is 0.33 times (Figure 5a). Ca/Si ratio is 15.85 for protected concrete and 2.2 for unprotected.

In the protected condition, there are two types of atomic energy of Ca: 0.25 and 3.7 keV, while in the unprotected condition there is only one type of atomic energy, namely 0.25 keV (Figure 5a). Based on this, the protected condition Ca is more difficult to determine than the unprotected condition.

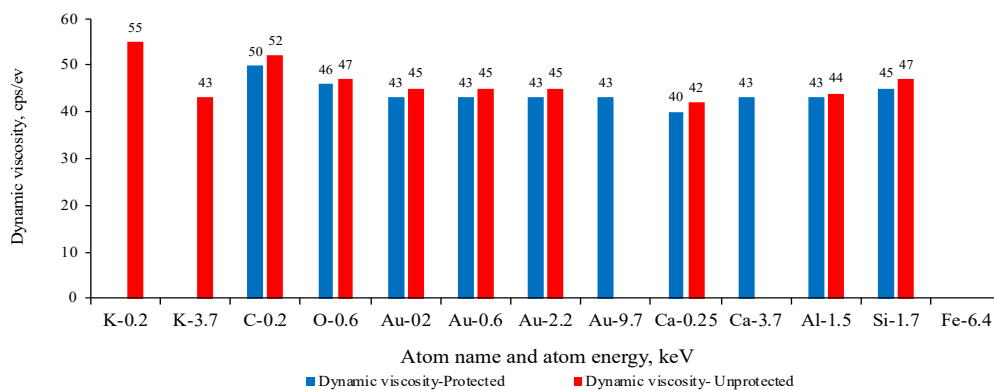
Figure 5b. EDX: Dynamic viscosity, and atomic energy of protected concrete, unprotected

The dynamic viscosity of the elements contained in the unprotected concrete is 2 cps/eV greater than the protected elements (Figure 5b). This means that the tangential force per unit area required to move one horizontal plane to another in the unprotected concrete is greater than the protected condition.

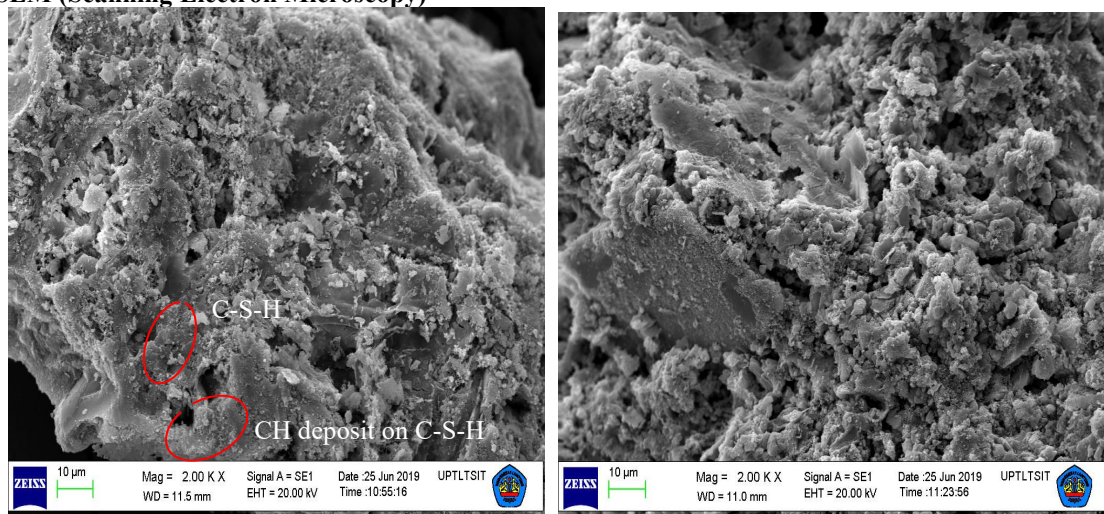
(a) (b)
Figure 6.1 SEM 2.00K: (a) Protected concrete, (b) Unprotected concrete

| Magnitude | SEM view of the concrete | |
|---|---|---|
| 2.00 K | Coarse & massive, small pores | Many lumps look brittle, there are even areas, more pores, smaller and more spread out |

Increased oxidation in the presence of potassium causes compounds with strong bases of pH 11 to 12 to decompose to bases with a pH of less than 9 [Hesa 2022]. With pH < 10.5, ettringite is lost. This is supported by Figures 6.1.b to 6.4.b. This pH value triggers a change in CSH. The exact decrease in CSH volume is difficult to quantify because it is a gel. The same difficulty is also in the case of portlandite crystals. The pH value < 10.5 causes CSH to collapse, break, towards the surface [Lagerblad 2001].

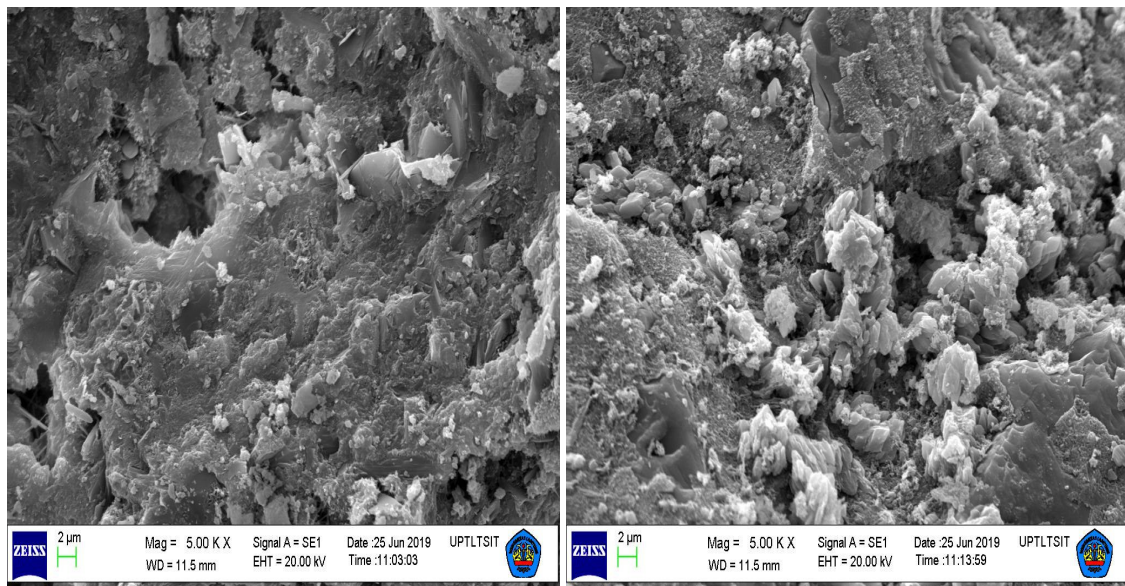
(a) (b)
Figure 6.2 SEM 5.00K: (a) Protected concrete, (b) Unprotected concrete

| Magnitude | SEM view of the concrete | |
|---|---|---|
| 5.00 K | CH crystals, clear CSH, very little calcite, deep visible pores | There is some rough crust covering the other parts, cracked, white lumps |

The thrust to the surface by the broken calcite and CSH, accompanied by heat due to Potassium and tropical temperatures causes some elements to crack (Figure 6.2.b). This crumbling CSH forms a dense silica gel layer, shrinks, the porosity increases markedly.

In the tropics countries the sun shines all day over the year, so; concrete will be drying and inner water will be evaporating. The dissolved particles dry out to form a crust (Figure 6.2.b). Sunlight and rain occur continuously, alternately. Because the pores are getting bigger and bigger, it makes the heat from the sun and rain water easier to get into the concrete. The material that occurs appears in the form of a smooth material that is pushed, layered and smooth. Other materials appear shaped like coral with many cavities. Calcite appears as white lumps that dominate the microstructure of the unprotected concrete (Figure 6.4.b).

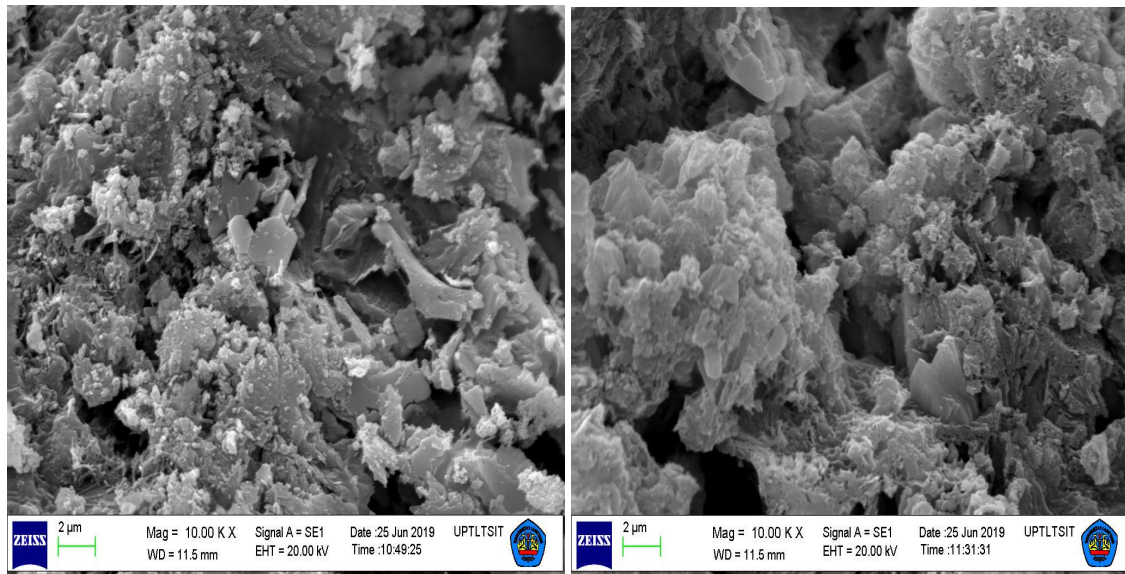
(a) (b)
 Figure 6.3 SEM 2.00K: (a) Protected concrete, (b) Unprotected concrete

| Magnitude | SEM view of the concrete | |
|---|---|---|
| 10.00K | CH and CSH look very massive, with many pores and deep | Large white blobs that look brittle, deep, and numerous |

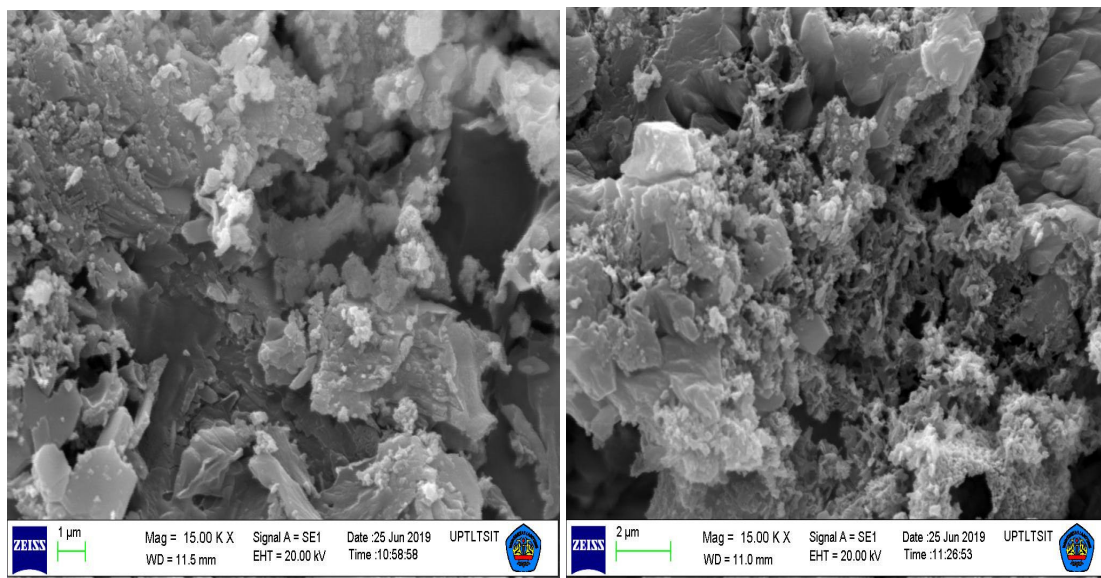
(a) (b)
 Figure 6.4 SEM 2.00K: (a) Protected concrete, (b) Unprotected concrete

| Magnitude | SEM view of the concrete | |
|---|---|---|
| 15.00K | CH and CSH are very massive, with very little calcite, and deep pores | There are white lumps that are smooth, smooth areas with uneven shapes, there are nodules, there are coral-like shapes with very many pores, there are shapes like ellipses with smooth walls and look soft, and the crust is not massive. |

With the presence of CSH, CH, and ettringite in the protected concrete it can be said that the protected concrete is in zone 6, where Al₂O₃ is low, MgO none, CaO/SiO₂ 1.6-1.7, Ca > 20 mmol/kg, Si < 1 mmol/kg, pH > 12.4, very low porosity [Lagerblad 2001]. Lime or CaCO₃ appears as small white lumps in very small amounts compared to other hydration products (Figure 6.4a).

- The rainy season alternates with the dry season. The Ca solution, and the precipitate, which occurs are formed gradually (Figure 6.4.a).
