FAILURE ANALYSIS OF THE FLOUR PRESS MACHINE AND ALTERNATIVE SOLUTIONS AT PT ANEKA USAHA LABA JAYA UTAMA PESAWARAN

ABSTRACT: Processing chocolate from dried cocoa beans to become a ready-to-eat chocolate paste involves a long process, including separating the cocoa oil from the flour. The separation process is mechanized using a press machine with high pressure at a certain temperature level. However, a press machine deals with obstacles prone to failure and damage. This study aims to analyze the causes of the chocolate pressing machine's failure using hydraulic pressure and find alternative repair solutions. The cylinder of the machine press is made of stainless steel material and has a cylindrical geometry with a diameter of 23 mm and a tube length of 30 cm. Failure analysis is carried out by observing the machine's operating conditions, the procedure for its use, and the load imposed on the machine, including, in this case, the service life to date. Observations were also made on the form of failure, the type of damage, and each component's function. Thus, based on the data obtained and relates to the theoretical theory, the conditions that should occur are obtained. The study r

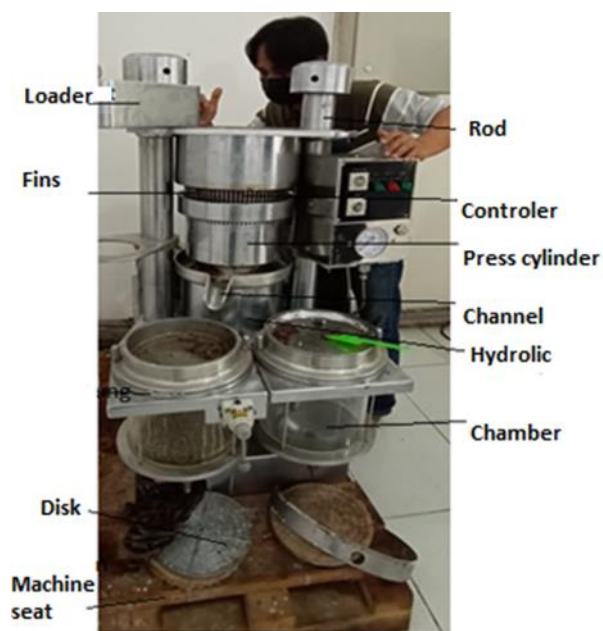
Fig. 2. Chocolate press machine used for producing high-quality cocoa oil.

Fig. 2 shows a chocolate pressing machine used to produce cocoa oil from cocoa flour generated by the hydraulic pump. This machine has a breakdown, but the cause of the breakdown is unknown. After the observations, some damages were obtained in the field. This press machine has several parts, including the retaining rod, controller, press tube, cocoa oil channel, and so on, as shown in Fig. 2. The main part of this machine is the press tube and fins

where the cocoa's oil is released after pressing. The press tube is used to press the cocoa powder inserted into the tube.

One part of the pressing machine that plays an important role, but its nature is the main support, namely the engine holder. The engine holder used to support the engine load consists of wood, so there is a possibility that it is not as sturdy as the load base that can accept heavy loads. Most engine seats are made of rigid materials, so they are not easily deformed, causing the engine to be in an uneven or tilted position. Concrete or iron castings are the best choices because this material is rigid and does not change its position easily [8]. When the engine is running, the vibration caused by the engine affects the position of the engine. Therefore, the engine mount must be rigid and hard to change position. Changing the position will cause the engine flatness to be not standard anymore.

In general, the failure of the chocolate pressing machine to operate is caused by the damage that occurs, and the main source of damage is the uneven placement of the machine, not following the standard; it causes the tilt of the position when operating.

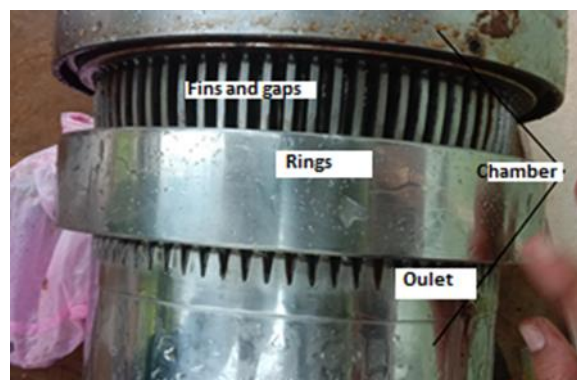
Fig. 3. The damages occurred on the press machine tube.

Fig. 3 is a hydraulic tube used for pressing cocoa powder to get oil as one of the chocolate products, which is very expensive. The brown tube consists of several fin rods tied with tie rings at the bottom, middle and top. The fins and tubes are made of stainless steel because the tool is used for food processing which must be protected from contamination. Consideration of strength is very good because it is made of stainless steel, which has a high level of strength. It's just that due to the wrong use process, or overload, it is possible to experience damage in the form of changes in shape.

The main part of tube one is the fin, where the brown oil drains into the container. The damage on the pressing machine is triggered by damage to the tube. The clogging of the gaps between the fins is caused by the accumulation of brown powder (granules) until it hardens. The hardening of cocoa powder in the gaps between the fins is triggered by not cleaning every time the machine is used. Even if the material that passes through the light is brown oil, it can harden and clog the gaps between the fins. High temperature or hot cocoa oil as a result of pressing pressure this condition accelerates the hardening of the cocoa powder that sticks to the tube. The lower fins and the gaps between the fins are clogged due to the accumulation of

hardened cocoa powder. The longer or more often used, the more cocoa powder accumulates in the gap area. The hardening of cocoa powder on the fins and the gaps between the fins can cause damage to the tube because if the pressure increases and no load comes out, it will impact the construction of the press tube [8-9].

The hole leading to the gap between the fins is located at the top of the ring. The function of the hole is to drain the brown oil from the top. The hole is clogged by powder material that has thickened and hardened. Improper usage procedures cause this condition. When the operator finishes using this press machine, the operator should clean the potentially clogged holes. Otherwise, the consequences could be worse. The blockage of several holes has prevented the brown oil from flowing into the reservoir. Oil will accumulate around the seal and cause the seal to be submerged by oil, and at that time, the working temperature is high, causing the seal to be damaged.

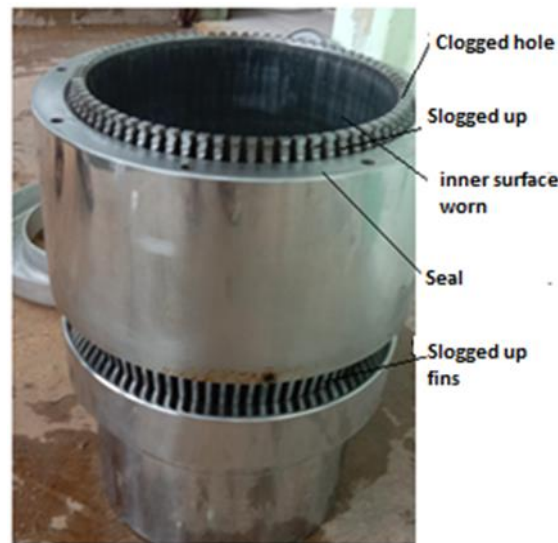
Fig. 4. The damages on the press machine tube and fins

Fig. 4 shows some of the damage to the brown press tube operated at the Pesawaran Regency BUMD Company, including clogged oil channel holes, clogged fins, worn inner surface of the tube, not tight seals, and the gaps between the fins were compressed. In general, several types of damage that occur to the tube press machine are caused by incorrect procedures for using the tool. An example of damage caused by incorrect machine operating procedures is the swelling in the gap between the fins. Every time after using the machine should be cleaned so that the remaining raw materials do not become dirty and cause damage. The material can accumulate in one place and then clump until it hardens. If it has hardened, then it can no longer be cleaned normally. It must be scraped to remove the hardened dirt.

The inner surface of the press tube wears out due to friction between the tube's inner wall and the hydraulic plunger's outer wall. This damage should not have occurred because between the two walls. There is already a gap, so it is impossible to rub against each other. Damage on the press wall tube is caused by friction caused by the movement of the plunger that is not centered. The machine is not located on a flat surface, so the plunger is not a flashlight-the position of the machine is not located on a flat plane. The wooden support at the base has changed the position of the machine, causing it to tilt. The damage to the inner wall of the tube occurred only on one side, so it was suspected that it was caused by friction between two surfaces.

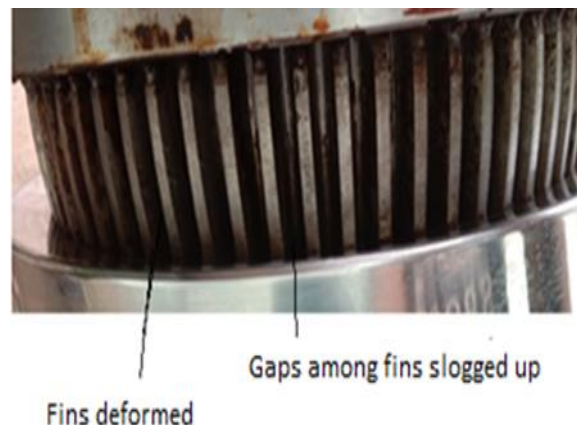
Fig. 5. A part of the fin experiences deformation and gaps among fins

The gap between the compressed fins was damaged because of the wrong procedure. There is also damage to the type of deformation or deformation of the fins, as shown in Fig. 5. The shape of the fins that were originally straight now looks not straight anymore. The distance between the fins looks not the same, so the fins can shift-this is caused by too much pressure during the pressing process [10]. It is also possible that due to the slits being compressed, the brown oil does not escape but contributes to the forced pressure on the fins. Not every fin changes shape, but only in certain parts. The hydraulic thrust may be uneven in all directions of the fin surface. This pressure unevenness is most likely due to the unstable position of the machine.

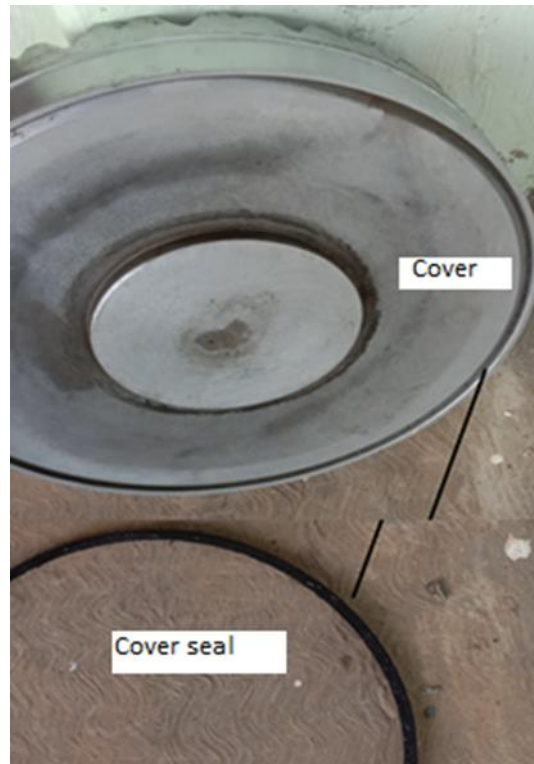
Fig. 6. The seal and tube cover

Fig. 6 shows the components of the chocolate pressing machine, namely the seal and the cover of the press tube. The tube cover is used to hold the cocoa powder, which comes out of the tube and is retained, thereby expelling the cocoa oil. In contrast, the seal is to close the two surfaces of the tube so that there is no gap between them [11]. If the two tubes are not tight, the cocoa powder will come out of the gap, and the pressure cannot be maximized. If there is a gap between the two surfaces, it can be categorized as leaking because the pressure will be reduced. It is estimated that the seal has not been replaced for a long time because its shape has changed

or is not in a circular geometry position—damage to the seal, most likely due to high pressure and temperature during pressing. The high temperature causes the seal to change and harden when it cools down again, making it stiff and difficult to fit in its original position.

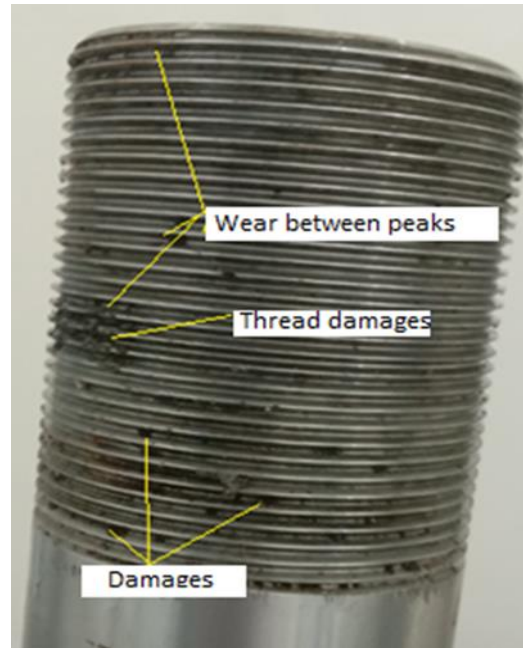
Fig. 7. Damages on the threaded rod

Fig. 7 shows a load-bearing hydraulic rod attached to both sides of the press, which consists of a straight section and a threaded section. Both parts of the supporting rods were damaged, and the damage that occurred was the wear surface of the straight rods. The wear that occurs on the threaded rod is due to friction unevenly along the length of the rod. The damage or thread defects occur in many places (either at the bottom of the rod or the top). Black color is widely spread along the threaded rod, and it is all damaged in the form of a peeling surface or partially corroded material. In certain parts, the damage accumulates in one place. An uneven load may cause it during operation. It can be ascertained that when the hydraulic presses with a full load, the threaded rods also hold a large amount because the support rods work as retainers.

Black color or holes are a type of damage to the threaded surface; most likely, this is caused by corrosion because oil or water can enter this area. A large load increases the movement of the damage. There is also some black color that is cocoa powder that sticks and hardens so that it looks like something hard sticks to the surface of the thread
