The Evolution of Concrete (Part 2): Unprotected in Humid Tropical Weather and Its Compression Strength

Chatarina Niken*

Civil Engineering Department, Faculty of Engineering, Lampung University, Jl. Sumantri Brojonegoro No 1
Bandar Lampung, Indonesia

This paper discusses the unprotected concrete in the basement which has been neglected for 10 years. The purpose of this study was to determine the compressive strength and microstructural changes in unprotected concrete in the humid tropics. The research was carried out experimentally. It was a case study at the State University Hospital, Lampung University, Indonesia. The compressive strength and microstructure of unprotected concrete compared to concrete in the protected condition. The compressive test samples were taken with 4 core drills for each condition. The compression test data was processed by the Outlying method. The microstructure of the concrete was examined by scanning electron microscopy (SEM), and energy-dispersive X-ray (EDX). The results showed that the compressive strength of unprotected concrete was 65% of the compressive strength of protected concrete. There are Kalium (Potassium) compounds in unprotected concre

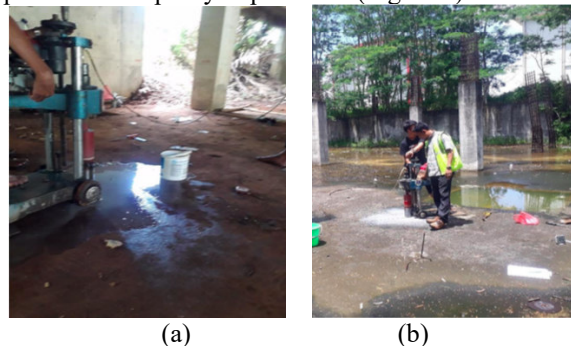
This research was conducted with a case study on the Basement Floor of the State University Hospital (RSPTN) of the University of Lampung in Lampung Province, Indonesia. This building has been neglected for 10 years. Part of this basement floor is protected and partly unprotected (Figure 1).

Figure 1. Basement condition: (a) protected, (b) unprotected

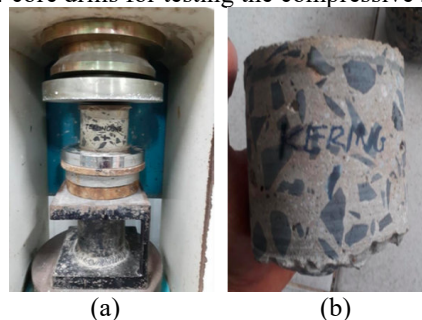
Each condition was sampled using 4 core drills for testing the compressive strength (Figure 2).

Figure 2. Drill core samples: (a) shielded, (b) unshielded

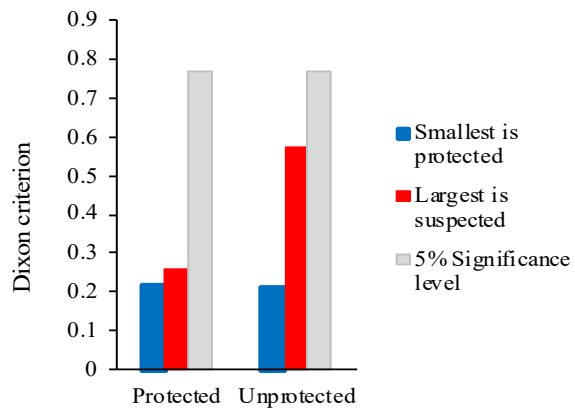
Figure 3. Examination of data

Compressive strength data is processed by outlining method. From this processing, the largest and smallest data values for protected and unprotected concrete are below the 5% significance level. Thus; all data can be accepted (Figure 3) and compressive strength can be calculated from the average data (Figure 4).

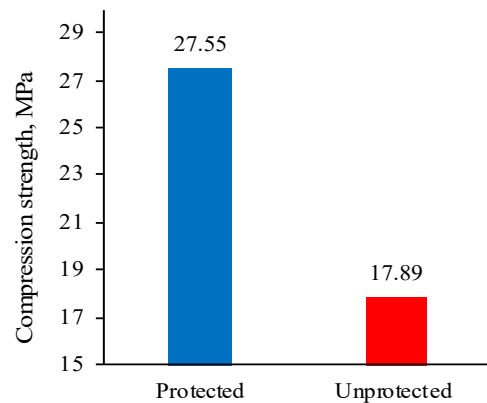
Figure 4. Compressive strength of concrete

The presence of an element that triggers oxidation and the presence of water makes unprotected concrete more fragile. The strength of the concrete decreases to 65% of the compressive strength of the protected concrete or 17.89 MPa while in the protected condition it is 27.55 MPa.

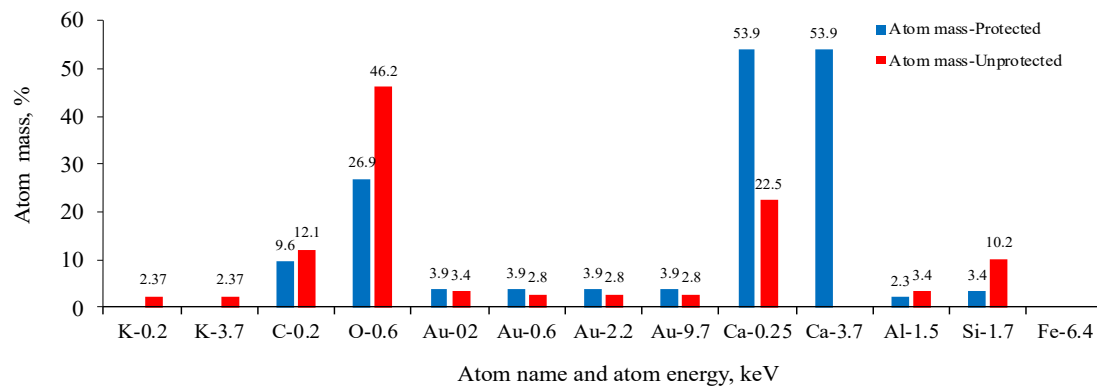
The relationship between energy, dynamic viscosity, and atomic mass is presented in Figure 5.

Figure 5a. EDX: atom mass, and atom energy of protected, and unprotected concrete

Kalium or potassium is the only element present in unprotected concrete but not in protected concrete (Figure 5a). Potassium shows a dynamic viscosity that is almost the same as other elements found in protected and unprotected concrete.

In the protected condition, the concrete compressive strength mainly comes from the contribution of C-S-H and CH. Elements of Ca and Si play a major role in the quality of concrete. The atomic mass of Ca in the protected condition is 2.4 times the unshielded condition, but the atomic mass of Si is 0.33 times (Figure 5a). Ca/Si ratio is 15.85 for protected concrete and 2.2 for unprotected.

In the protected condition, there are two types of atomic energy of Ca: 0.25 and 3.7 keV, while in the unprotected condition there is only one type of atomic energy, namely 0.25 keV (Figure 5a). Based on this, the protected condition Ca is more difficult to determine than the unprotected condition.

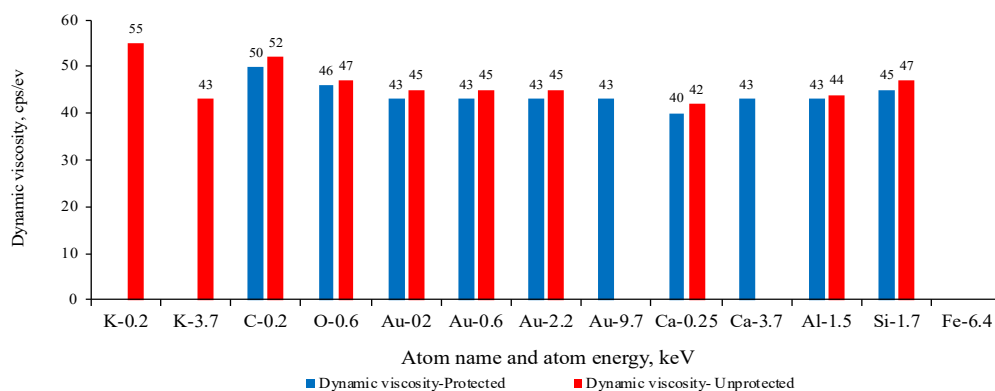
Figure 5b. EDX: Dynamic viscosity, and atomic energy of protected concrete, unprotected

The dynamic viscosity of the elements contained in the unprotected concrete is 2 cps/eV greater than the protected elements (Figure 5b). This means that the tangential force per unit area required to move one horizontal plane to another in the unprotected concrete is greater than the protected condition.

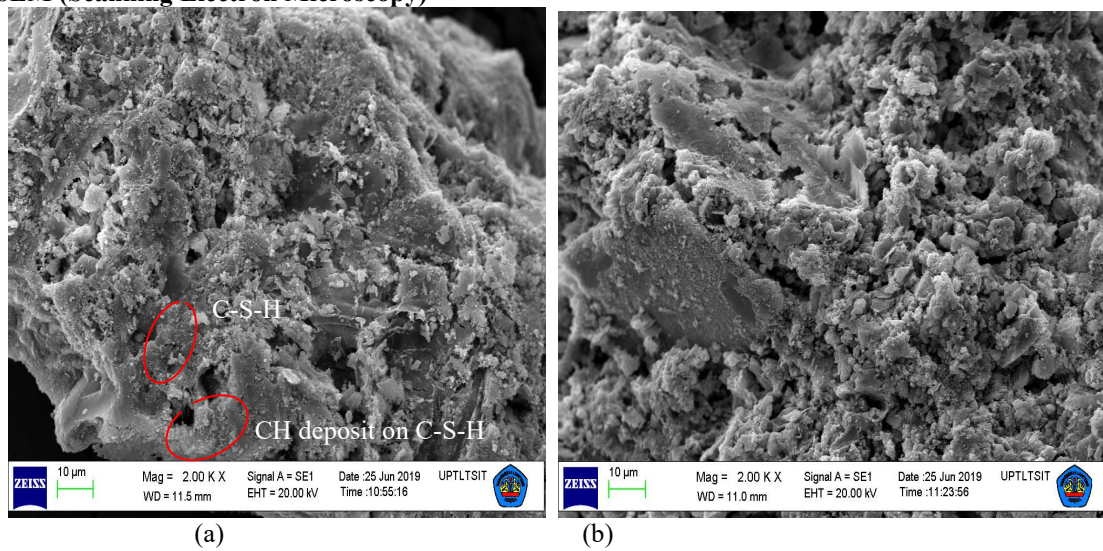
Figure 6.1 SEM 2.00K: (a) Protected concrete, (b) Unprotected concrete

Increased oxidation in the presence of potassium causes compounds with strong bases of pH 11 to 12 to decompose to bases with a pH of less than 9 [Hesa 2022]. With pH < 10.5, ettringite is lost. This is supported by Figures 6.1.b to 6.4.b. This pH value triggers a change in CSH. The exact decrease in CSH volume is difficult to quantify because it is a gel. The same difficulty is also in the case of portlandite crystals. The pH value < 10.5 causes CSH to collapse, break, towards the surface [Lagerblad 2001].

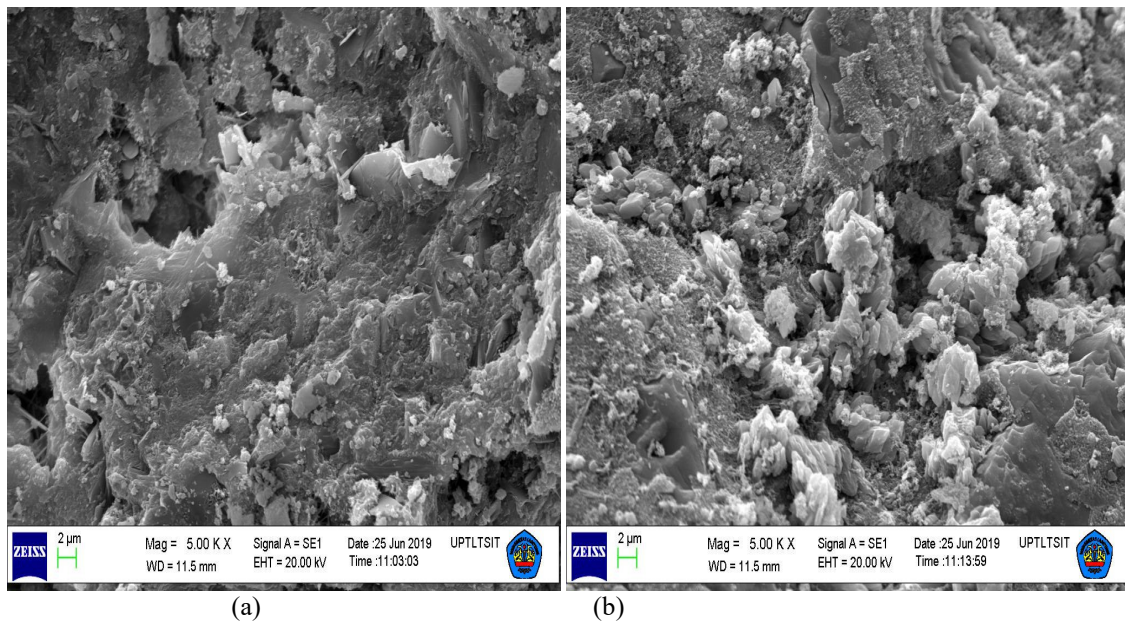
Figure 6.2 SEM 5.00K: (a) Protected concrete, (b) Unprotected concrete

The thrust to the surface by the broken calcite and CSH, accompanied by heat due to Potassium and tropical temperatures causes some elements to crack (Figure 6.2.b). This crumbling CSH forms a dense silica gel layer, shrinks, the porosity increases markedly.

In the tropics countries the sun shines all day over the year, so; concrete will be drying and inner water will be evaporating. The dissolved particles dry out to form a crust (Figure 6.2.b). Sunlight and rain occur continuously, alternately. Because the pores are getting bigger and bigger, it makes the heat from the sun and rain water easier to get into the concrete. The material that occurs appears in the form of a smooth material that is pushed, layered and smooth. Other materials appear shaped like coral with many cavities. Calcite appears as white lumps that dominate the microstructure of the unprotected concrete (Figure 6.4.b).

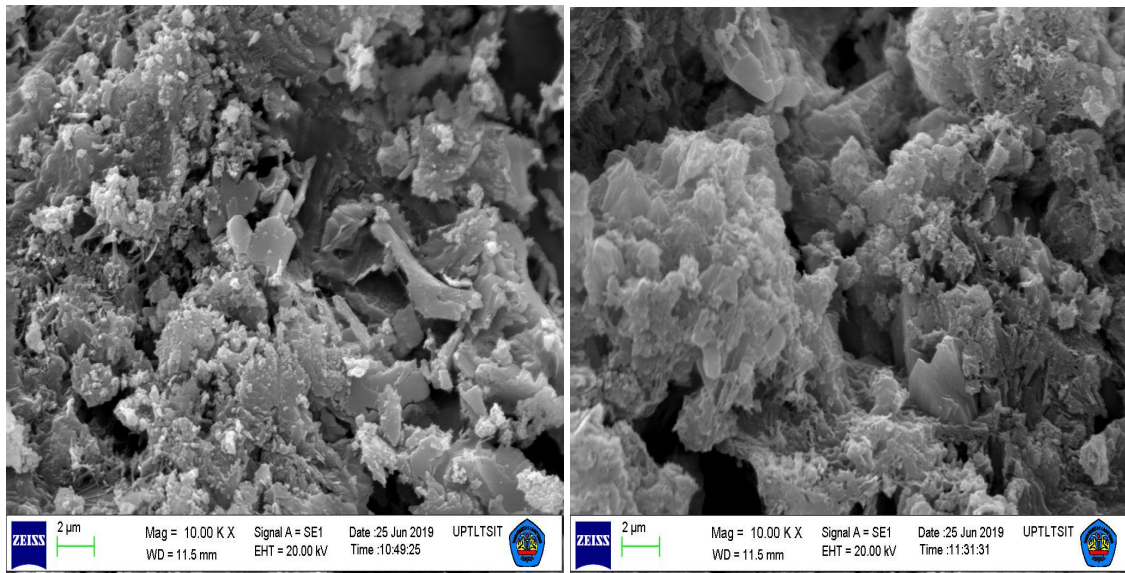
(a) (b)
 Figure 6.3 SEM 2.00K: (a) Protected concrete, (b) Unprotected concrete

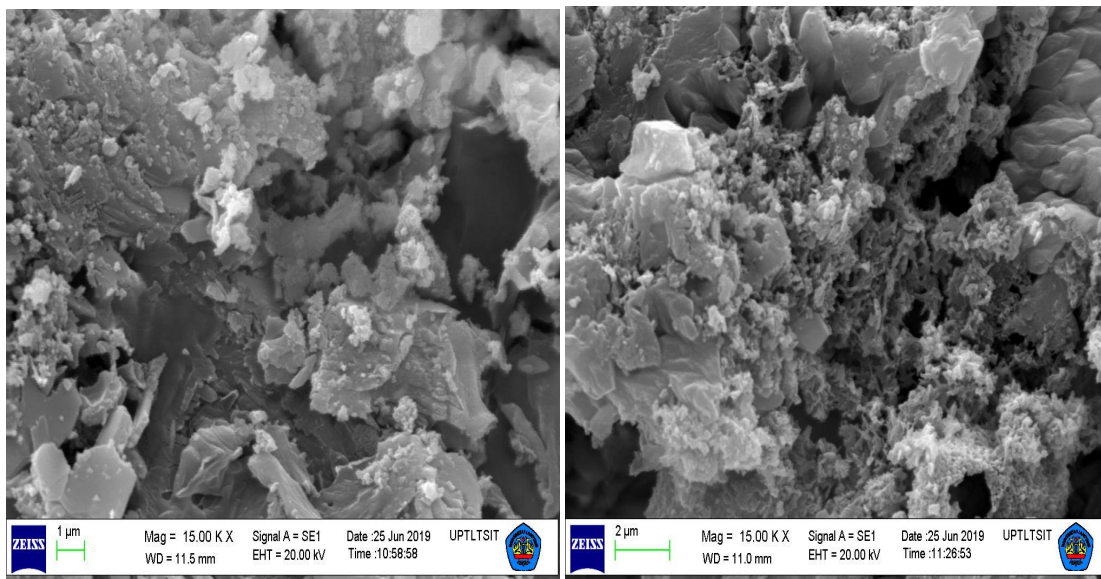
(a) (b)
 Figure 6.4 SEM 2.00K: (a) Protected concrete, (b) Unprotected concrete

With the presence of CSH, CH, and ettringite in the protected concrete it can be said that the protected concrete is in zone 6, where Al₂O₃ is low, MgO none, CaO/SiO₂ 1.6-1.7, Ca > 20 mmol/kg, Si < 1 mmol/kg, pH > 12.4, very low porosity [Lagerblad 2001]. Lime or CaCO₃ appears as small white lumps in very small amounts compared to other hydration products (Figure 6.4.a).

- The rainy season alternates with the dry season. The Ca solution, and the precipitate, which occurs are formed gradually (Figure 6.4.a).
