Number: 4602/UN26.21/PM.01/2021

Potential hazard analysis and mechanism of landslide and debris flow in Semaka, Tanggamus

Aminudin Syah[1,a], Amril Ma'ruf S.[1], Riki Chandra W.[1]

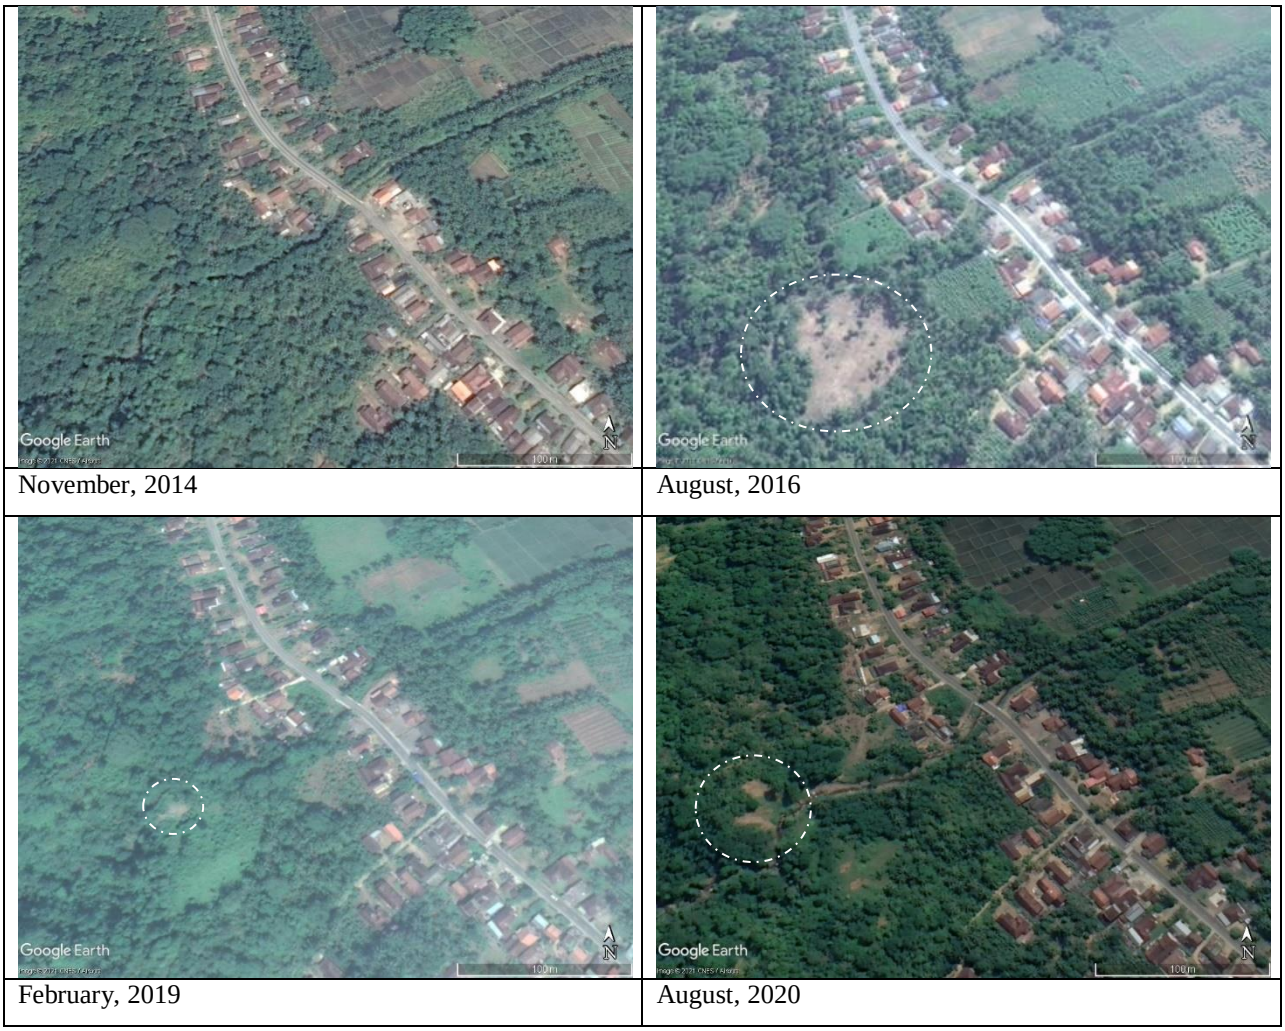
Morphology before the landslide was obtained from Google Earth satellite data and DEMNAS imagery data with a resolution size of 8 m. land use in the area around landslides and floods did not change significantly. In November 2014, the upstream of the river was still dense vegetation. The flow path was visible, and no landslides or erosion along the river bank (Figure 4). In August 2016, the slope of the right side of the river channel was exposed for 100 m. The landslide material moves to the river channel. In February 2019, the landslide occurred on the left side of the river bank and seemed to be getting bigger in August 2020. The landslide material moves to the river and can transform into a debris flow or flash floods.

The landslide located at an elevation of 55 m to 90 m while the river flow is at an elevation of 50 to 450 m. Morphology after erosion is derived from UAV data with resolution size of 1 m. DEMNAS and DEM data from the UAV were combined to obtain an overview of the landslide area, river channel and affected area (Figure 5).

FIGURE 4. Geomorphology before and after lansdlide

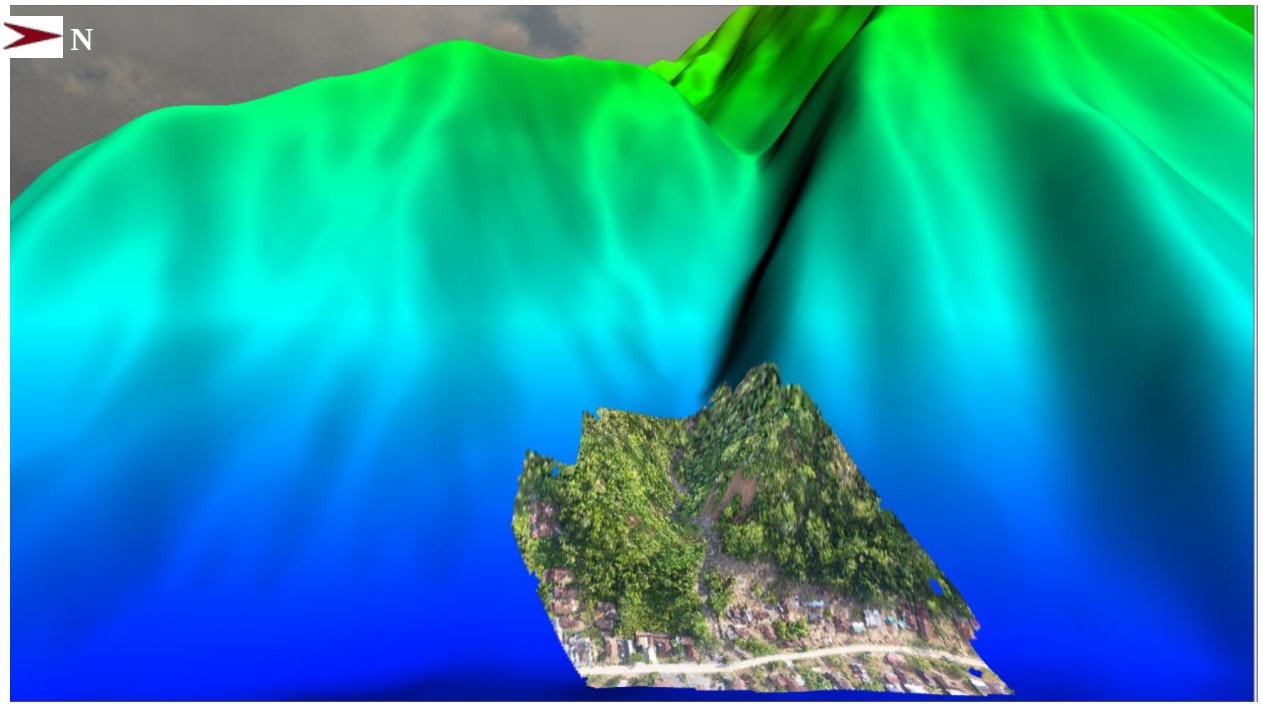
In this research area, there are two types of rock, namely andesite, and breccia. Breccia is found as avalanche material mixed with other igneous rocks. Andesite rocks are the original rocks that make up the geology of this area. Based on the geological structure, this area is traversed by faults and lineaments so that it has potential landslides. The geological structure of the study area is characterized by lineament patterns resulting from morphological formations controlled by endogenic activity. Lithology in the form of andesite and landslide material in the form of volcanic breccia with a high level of weathering produced a thick layer of soil. The soil layer consists of montmorillonite clay which is on top of bedrock in the form of andesite which is very susceptible to causing soil movement when triggered by water.

FIGURE 5. Combination of DEMNAS and UAV imaginary data

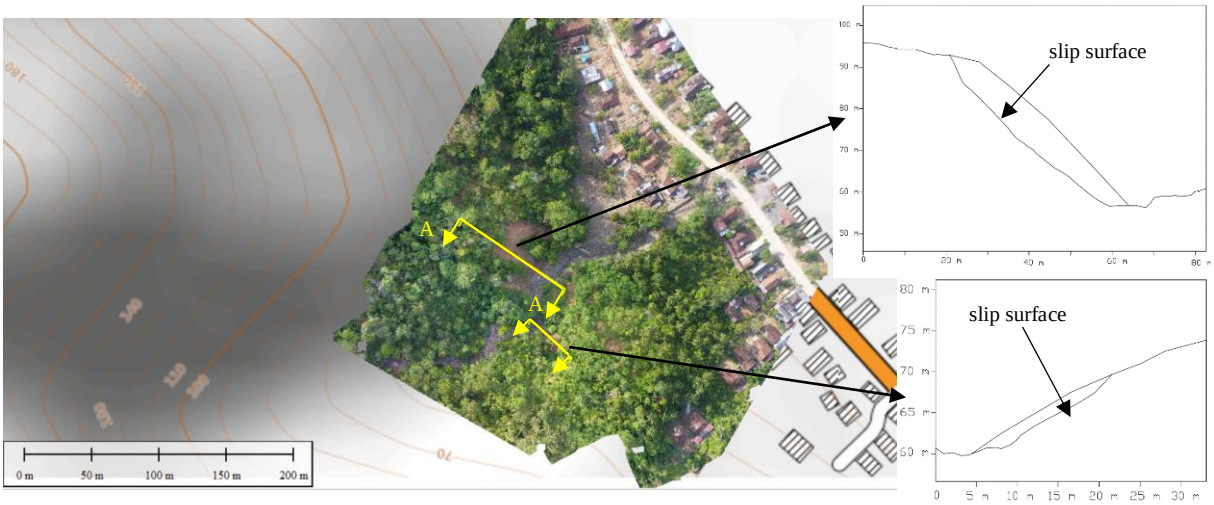
Landslide geometry is constructed based on a comparison of morphology pre-landslide with post-landslide and geotechnical properties of landslide. The upper layer is composed of sandy clay, and the lower layer is composed of andesite breccia. In this study, two slopes are modeled and analyzed using the limit equilibrium method. The two slopes are on the left and right sides of the river bank and are shown in the yellow line (Figure 6). The slopes are at an altitude of 55 to 90 m.

In this study, the slip surface is assumed to be a complex type. The slip surface is non-circular and a combination of rotational and translational. The top layer is sandy clay soil while the bottom layer is andesite breccia. The actual landslide slip surface was obtained from the UAV data after the landslide and was used as the initial condition of the slope geometry.

FIGURE 6. The cross section of Sedayu landslide

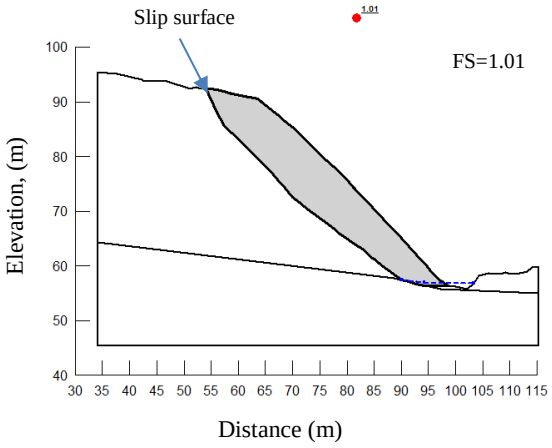
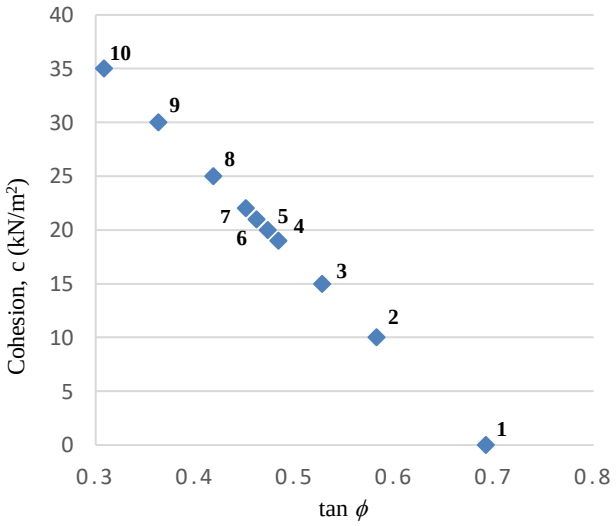
FIGURE 7. Back analysis with limit equilibrium method

In the initial model, the slope is modeled with the groundwater level approaching the river water level, which is about 1 m. Cohesion and internal friction angle were analyzed by trial and error with the closest condition to the actual condition during it collapsed. The shear strength parameters from the triaxial test and direct shear test can be used as a reference to conduct trial and error on the cohesion and internal friction angle.

The result of slope stability analysis using the limit equilibrium method in the actual condition during collapse is shown in Figure 7a. Slip surface is simulated similar to that occurs in the field based on the field surveys and mapping. The values of c and ϕ were tried to result from the same slope model with field conditions. The relationship between the values of c and tan ϕ is linear as shown in Figure 7b. The value of the internal friction (ϕ) and cohesion (c) which results in the value of FS=1 is number 5 in Figure 7c. The results of the analysis show that the value of the soil shear strength parameter for the slope is c=20 kN/m^2; ϕ=24.78°. The soil shear strength parameter as a result of the back analysis is still in the range of laboratory test results.

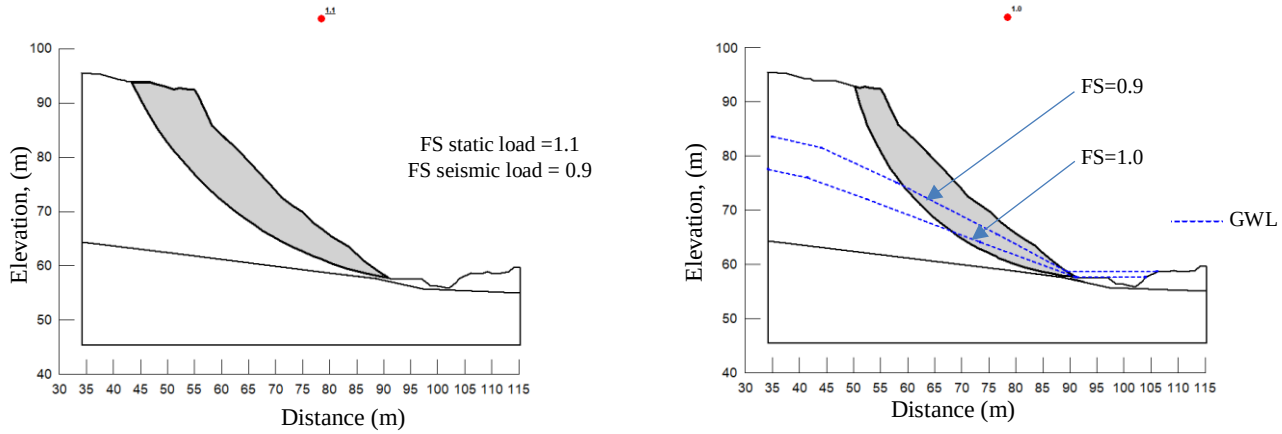
The result of modeling on the actual condition shows that the value of SF without any increase in groundwater level is 1.1. It means that the slope has not yet collapsed, even though it is in a critical condition. If there is an increase in seismic load, for example, an earthquake the slope becomes unstable with a safety factor value of 0.9 (Figure 8a). High intensity or long-duration rainfall can cause groundwater level rise. High intensity or prolonged rainfall can cause groundwater levels to rise and slopes to become unstable or collapse. SF decreased from 1.1 to 1.0 and 0.9 due to the increase in groundwater level as shown in Figure 8b.

Landslide materials move to the river and can transform into flash floods or debris flows. With a channel width that is not too large, landslide material can block the flow path. This event resulted in the occurrence of a natural dam, if it collapses it can transform into a flash flood. Landslides and floods that occurred in the past caused the Kota Agung-Bengkulu road's broken and inundate residents' houses as high as 1-1.5 m. Therefore, structural mitigation in the form of slope protection, reinforcement and drainage improvement on unstable slopes needs to be done to reduce the risk of disasters caused

FIGURE 8. earthquake or groundwater induced slope failure
