THE MECHANISM OF MISALIGNMENT OF SAW CUTTING CRACKS OF CONCRETE PAVEMENT

Fracture Mechanics Applications

The Mechanism of Misalignment of Saw Cutting Crack of Concrete Pavement

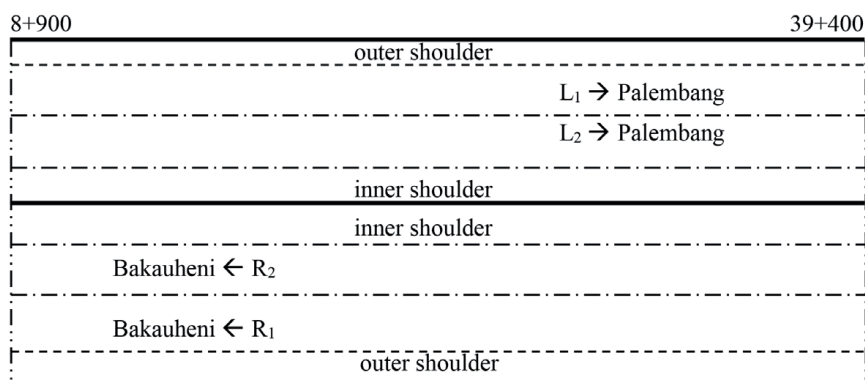
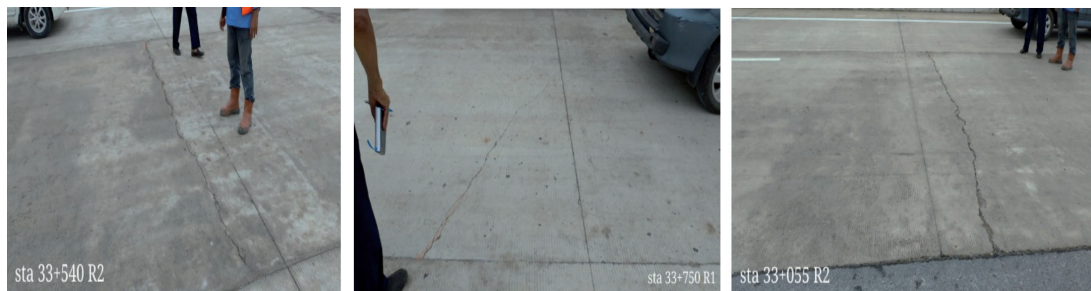
Figure 4.
Real concrete pavement scheme.

The observation was done in the Bakauheni-Palembang road, Lampung Province, Indonesia, with 30,000 m length. The concrete pavement has four lanes (**Figure 4**). In this observation, the dowels have 32 mm diameter and 70 cm length, and the space between two dowels is 30 cm.

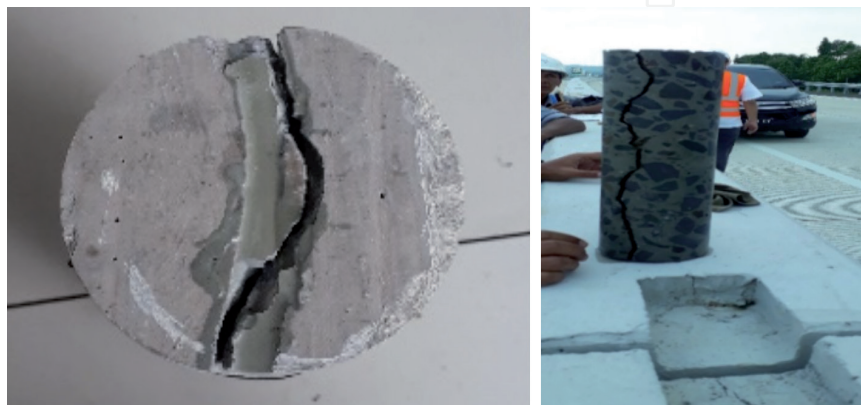
Misalignment cracks are the second part of the three types of damage (**Table 1**). Eighty to ninety percent of the misalignment cracks occur on dowels that experience shifting or late cutting. The crack width is 1.5–2 cm with 30 cm depth or until the base of rigid pavement (**Figure 6**).

This damage is serious because it gets to the bottom of the concrete pavement. Understanding the mechanism of the occurrence of misalignment cracks is expected to trigger construction implementers to take preventative actions based on an understanding of the seriousness of the damage that will occur.

Figure 6.
Width and depth of misalignment crack.

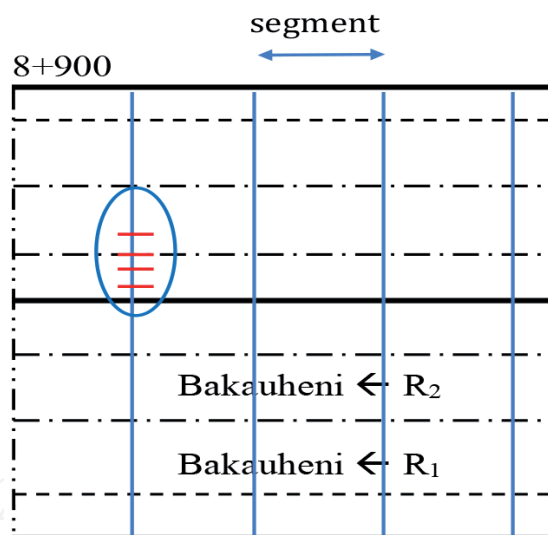
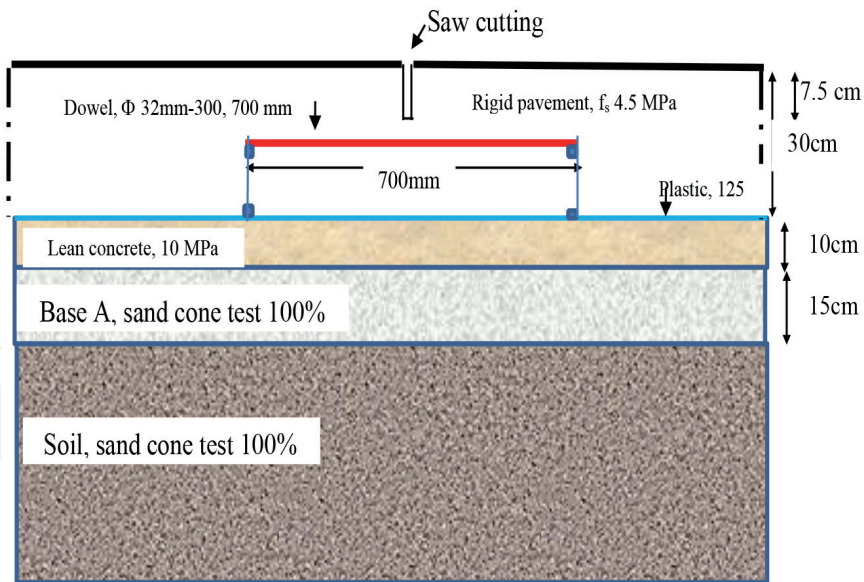
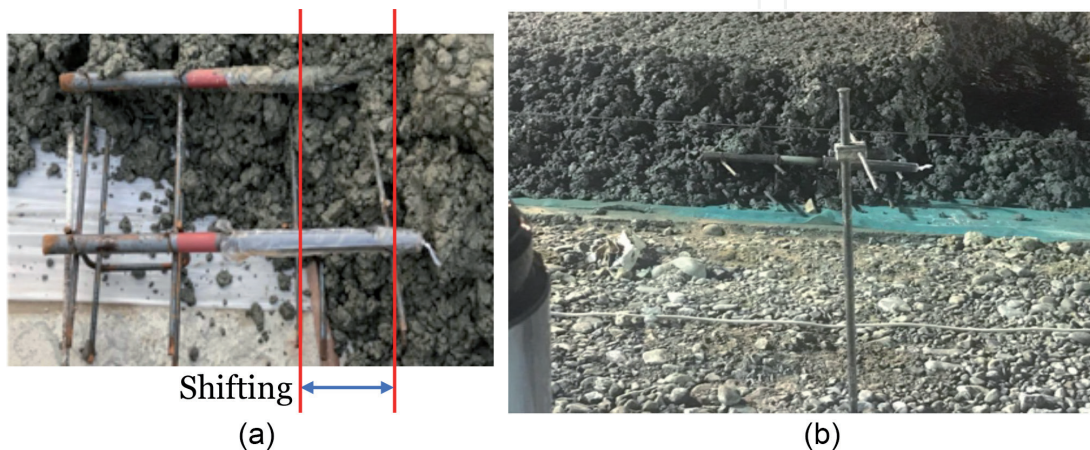
Figure 7.

In general, concrete pavement is intended for heavy loads. To transfer the burden, dowels are required. Dowels made of plain reinforcement are installed between two segments (**Figure 7**).

*Segment and dowel.*

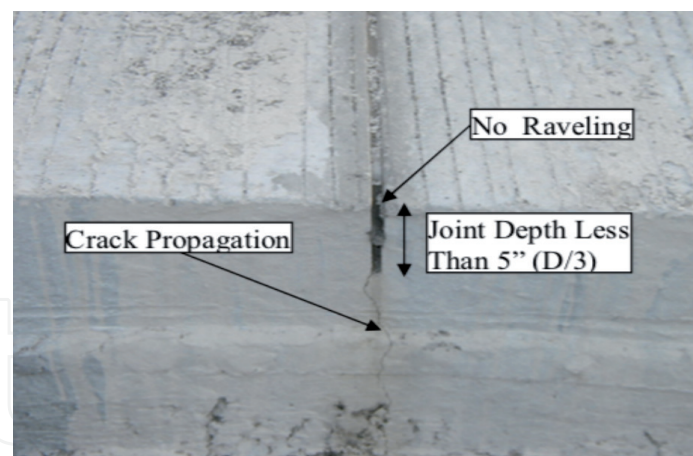
Figure 12.
Cracks occur at the planned place.

Placement of the correct dowel position and sawed in window cutting time result a crack occurring right in the saw cutting line (**Figure 12**). When saw

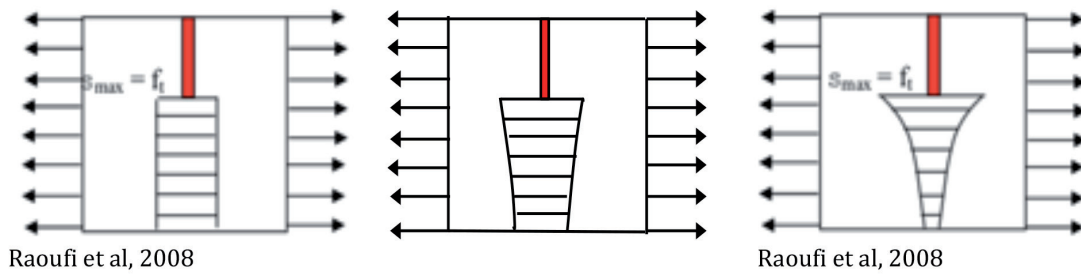
Microcracking appears below the notch (**Figure 13a**). On cutting as deep as D/2, there is still a microcracking area that has not been covered (**Figure 13b$_1$**). This microcracking force will spread sideways and cause weakness in other areas. Whereas on cutting as deep as D/3, it can be said that undamaged areas are very thin (**Figure 13b$_2$**). On cutting as deep as D/4, the layer of area that protects against the distribution of microcracks is sufficient (**Figure 13b$_3$**). The distribution of concrete stresses under the saw cutting is as shown in **Figure 14**.

Figure 13.
Process and cracks area, (a) fracture process zone (FPZ), (b) FPZ in D/2, D/3, D/4 [13].

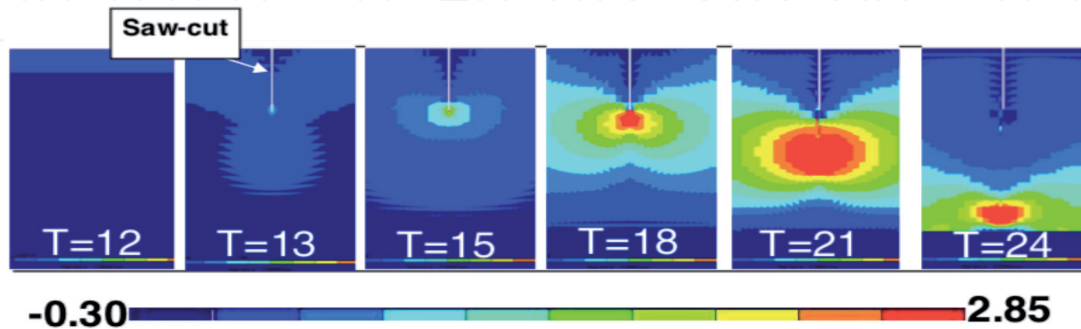
Concrete conditions when misalignment cracks are at the age of 18–72 are between plastic and brittle. Stress distribution at this time was assumed as shown in **Figure 14b** that is a transition between that shown in **Figure 14a** and **c**.

Figure 14.
Stress distribution: (a) plastic failure, (b) plastic-brittle failure, and (c) brittle failure [13].

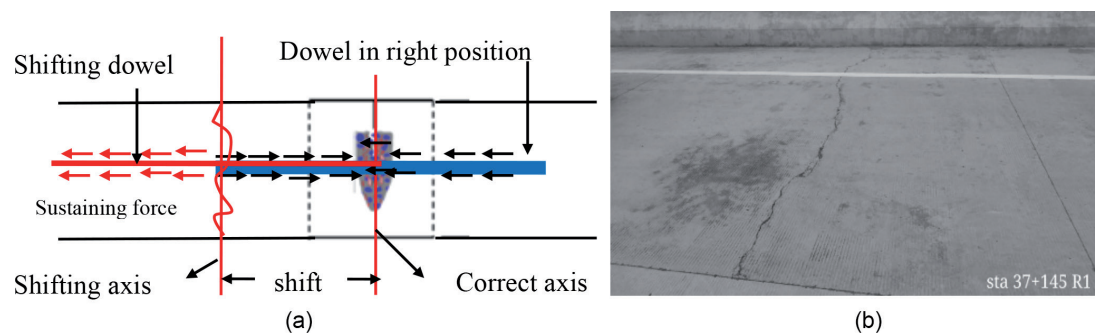
Dowel can shift from the right position (**Figure 11**) due to the pounding of fresh concrete pouring or because it is displaced by a paver (**Figure 10**). Naturally, there are shear force between dowel and concrete. Shifting dowel makes unbalanced shear force between both sides of the cutting line. Addition with microprestress and concentrated stress at the lower end of the saw cutting separates unevenly due to the dowel shift and increases unbalanced stress on both the sides. To be balanced, then when cutting arises the pulling force of restraint (**Figure 24a**). The consequence of this is that cracking does not occur in the cutting line but shifts at the starting point of the holding force.

The microprestress can reach 2.73 MPa as in item 4.2.5; if added dowel frictional force and stress concentrated at the lower end of the notch can exceed the strength of concrete that is 5.5–6.9 MPa (point 3.3). This can cause microcracks to arise in the concrete. The microcracks and high stress at one side of the cutting line lead to misalignment cracks (**Figure 24b**).

Figure 24.
Dowel in shift position: (a) shifting dowel and unbalanced stress, (b) misalignment crack.

Asymmetrical conditions of stress occur on both sides due to the dowel shift. There have been weak points at locations outside the saw cutting line (**Figure 24**). As a result, transversal cracks can arise outside the saw cutting line. Condition as mentioned in 4.4.2.1. can also occur. Unbalanced condition between shear force between both the sides of cutting line increases by the spread of large stress at the end of cutting depth and unbalanced bouncy force on both the sides of the cutting line. The unbalanced force leads misalignment cracks to occur on the side of the shift direct dowel.

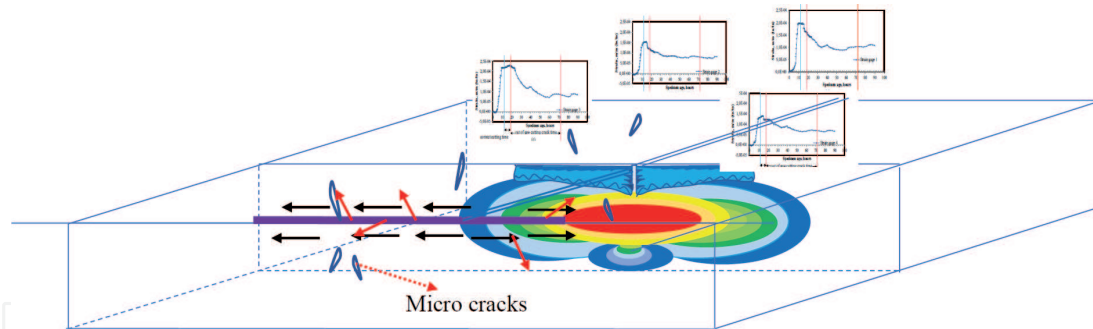
Figure 25.
Bouncy force of microprestress.

condition is marked by the end of ettringite growth. Based on this and **Figure 17**, it begins at around 18 hours of age. Distribution of stresses under the saw cutting is wider to both sides in brittle condition than in plastic condition (**Figure 14c** and **a**). Estimates of stress contours under brittle conditions are presented in **Figure 25**.
