The investigation of avalanche patterns on railroad tracks with steep slopes

Lusmeilia Afriani* and Iswan

Civil Engineering Department, Universitas Lampung, Bandar Lampung, 35145, Indonesia

Abstract. This study aims to investigate the pattern of landslides on the cliffs forming the railway with steep slopes. This research was conducted at Rejosari Natar Station, South Lampung Regency, Lampung Province. The point of observation is at STA 30 + 250. The data in this study were divided into primary and secondary data. Primary data is the data that is directly obtained in the field by taking soil samples which are then processed in the laboratory. The secondary data is the soil characteristics data of the railroad structure starting from the rail load, rail bearings, ballast layers, sub-ballast layers, and sub-grade. These will be used as input in conducting railroad analysis using Plaxis modelling. Plaxis modeling requires these variables and parameters to be analyzed based on the amount of vertical settlement, total stress, and safety factor values that occur due to rail loads. Reserach found that the value of the soil safety factor was <1.25 . This means that the soil condition is

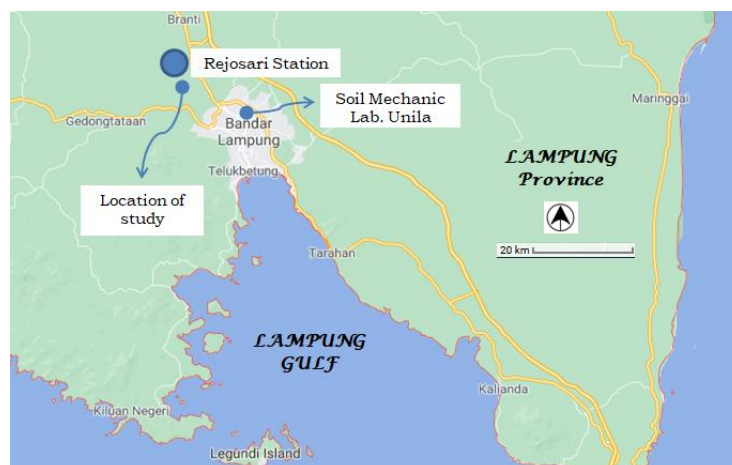
Figure 1. Study location

This research was conducted at Rejosari Natar Station at the observation point of STA 30 + 250. Rejosari Station is a train station located in Natar District, South Lampung Regency. The distance is approximately 19 km from Tanjung Karang Central Station, Lampung. Rejosari Station is a Class II train station located at an altitude of +104 meters above sea level. Administratively, this station is under Regional Division IV Tanjungkarang.

This station has four railway lines with line 3 being a straight line plus eight special lines in the workshop area. At this station, there is a coal train maintenance workshop that sends coal from the Bukit Asam coal mine, South Sumatra Province, to the Tarahan power plant in Lampung Province. This coal carrier train is the longest train in Indonesia, which is approximately 600 m long with a maximum series of 50 carriages. This train is capable of making 50 trips from Bukit Asam to Tarahan every day and supplies several hydropower plants in Java Island apart from PLTA Tarahan in Lampung Province.

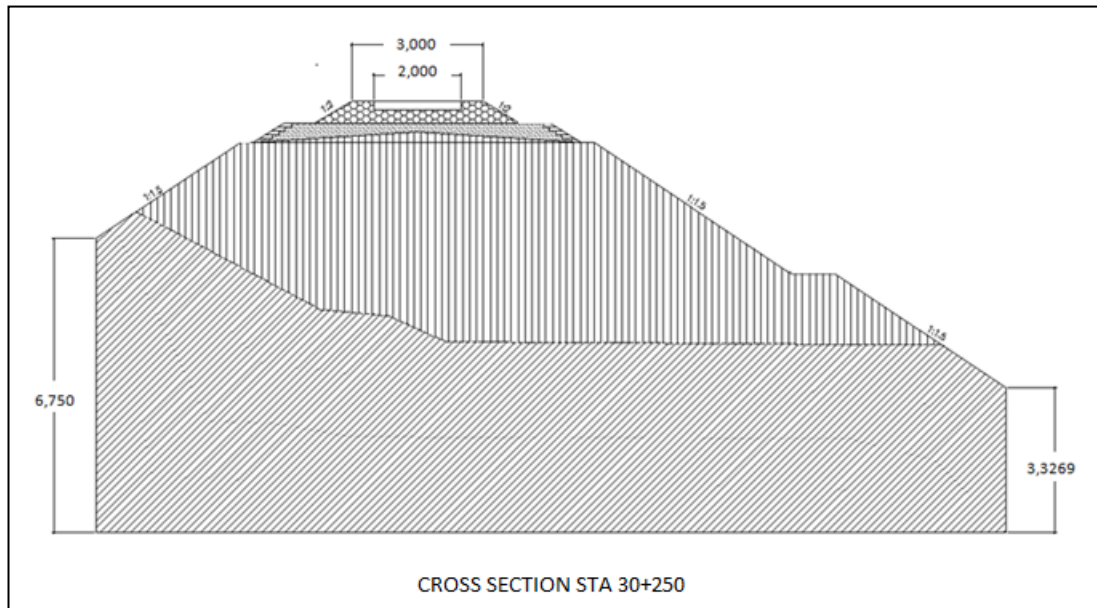
Figure 2. Cross section in the location of study
