# The Evolution of Concrete (Part 3): Submerged in Mud and Its Compression Strength

## The Evolution of Concrete (Part 3): Submerged in Mud and Its Compression Strength

Chatarina Niken\*

Civil Engineering Department, Faculty of Engineering, Lampung University, Jl. Sumantri Brojonegoro No 1  
Bandar Lampung, Indonesia

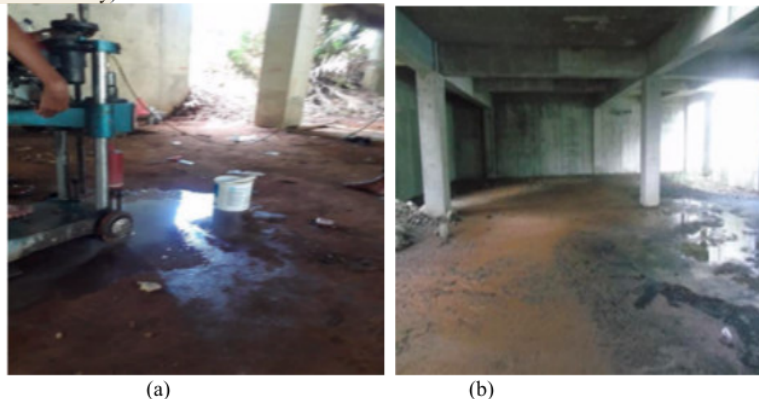
Figure 1. Concrete condition: (a) Protected concrete, (b) Concrete submerged in mud

The PTN Hospital, University of Lampung, Indonesia which had been neglected since 2010-2020. The basement was submerged in water mixed with mud from the soil cliffs at the location for a period of 10 years. Samples were taken by core drill at locations that were submerged in mud and protected by a minimum of 4 samples each (Figure 1). The samples were used for compression testing, SEM (scanning electron microscopy), and EDX (energy dispersive X-ray).
