Study of Coastline Shifts on the West Coast of Lampung Using Remote Sensing Data

This study specifically aims to identify coastal abrasion as seen from the coastline shift, from 1989 to 2020 in Pesisir Utara Sub-district and Lemong Sub-district, Pesisir Barat Regency, Lampung Province, by interpreting remote sensing data. The data used are Landsat satellite imagery for 1989, 2000, 2006, and 2020. Landsat satellite imagery are corrected by radiometric and geometric correction. The geometric correction is registered to Landsat imagery in 1989. The corrected satellite imagery is digitized for the coastline. The results of the digitized coastline were then overlaid, then the coastline shift was calculated from 1989 to 2020. The coastline shift calculation was carried out at 16 locations in Pesisir Utara Sub-district and Lemong Sub-district. The results of calculations at 16 sample locations show that there has been a shift in the coastline due to coastal abrasion from 1989 to 2020 of 2.0 m/yr. For areas where the coastal conditions are rocky and there are shallow rocks in front of it, the coastline shift is only small, such as in the cape area before Walur Village. This coastline shif

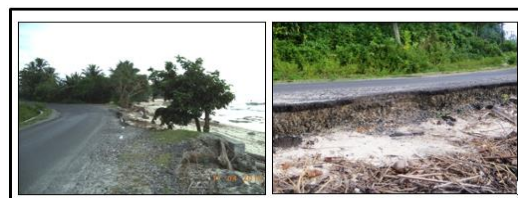
Figure 1. The condition of the west cross road in Lemong Sub-district has been affected by abrasion

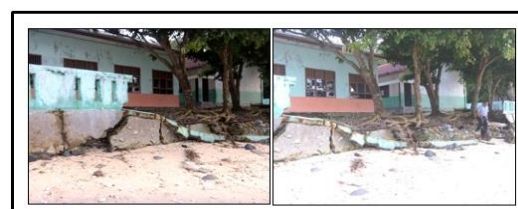
Figure 2. The condition of the coast behind SMAN 1 Lemong

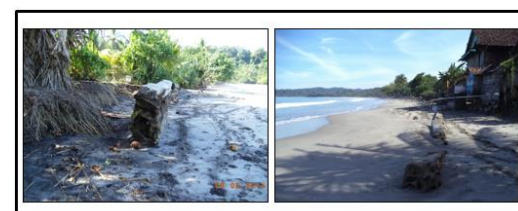
Figure 3. The condition of the coast behind Balam Village

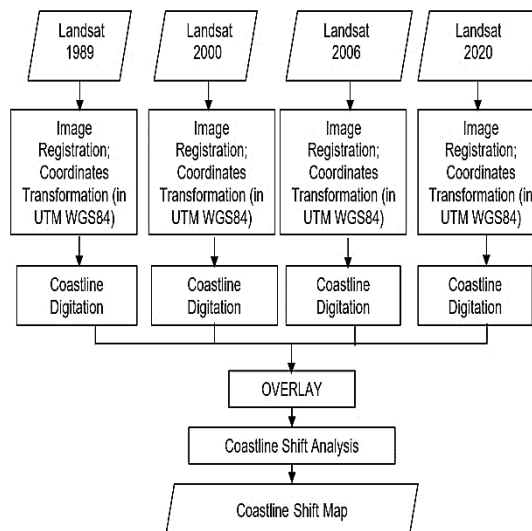
Figure 5. Flowchart of research implementation

The flowchart of the research implementation can be seen in fig. 5. The final results of this study were maps of the coastlines for 1989, 2000, 2006, and 2020, along with their shift values from every year. The satellite imagery data used are

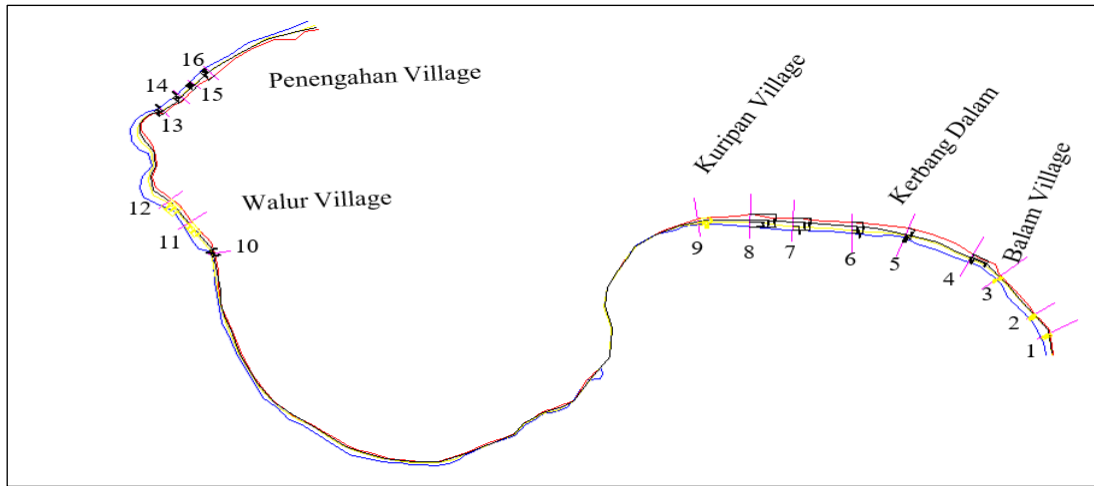
Figure 7. Digitized coastline results from Landsat satellite imagery

The sharpened and geometric corrected imagery are then exported to the Quantum GIS application program. The corrected Landsat satellite imagery for 1989, 2000, 2006 and 2020 were then digitized for the coastline. Digitization is done by on screening. The result of this digitization is then the calculation of the coastline shift with the initial reference to the 1989 image. The digitized coastline of each Landsat image can be seen in Fig. 7. There are 16 (sixteen) locations where the coastline shift is calculated, namely 3 locations in Balam Village, 4 locations in Kerbang Dalam, 2 locations in Kuripan Village, 3 locations in Walur Village, and 4 locations in Penengahan Village. These locations were chosen because the soil structure is sandy beaches which are prone to abrasion due to natural phenomena.

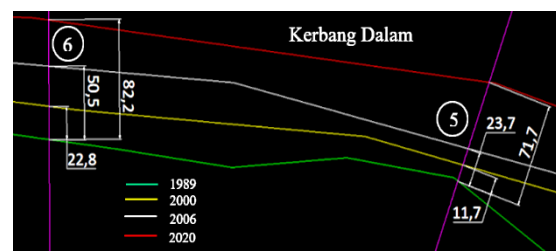
Figure 10. Coastline shift on location 5 and 6

The sixteen locations whose coastline shift values were calculated can be presented in Fig. 8 to 13, while the results of the coastline shift calculation from 1989 to 2020 can be seen in table 1.

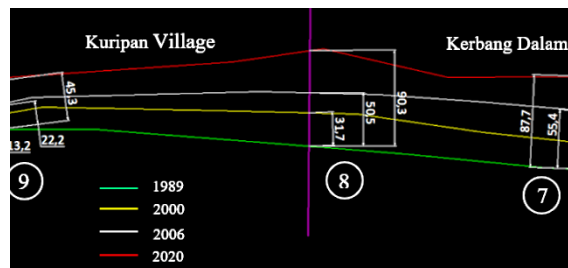
Figure 11. Coastline shift on location 7-9

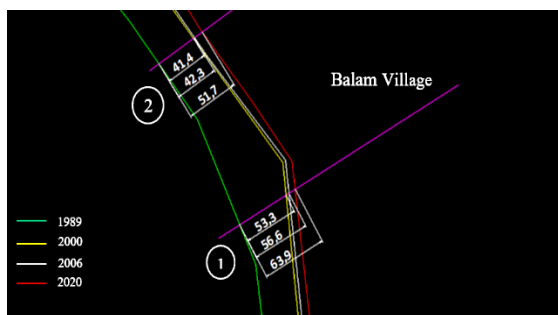
Figure 8. Coastline shift on location 1 and 2

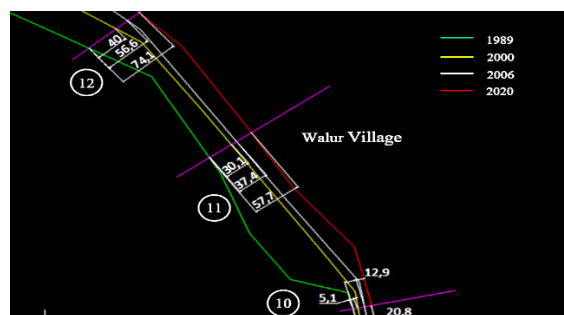
Figure 12. Coastline shift on location 10-12

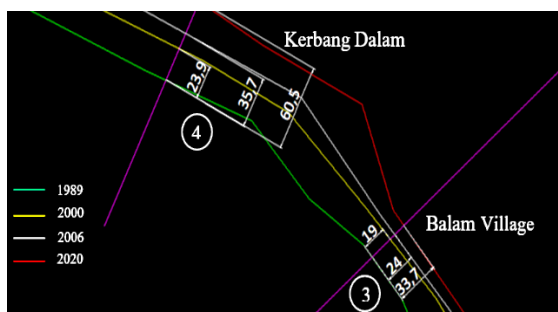
Figure 9. Coastline shift on location 3 and 4

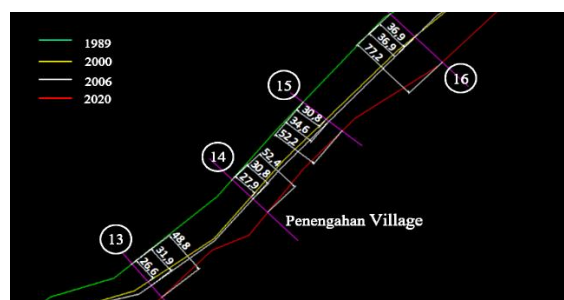
Figure 13. Coastline shift on location 13-16

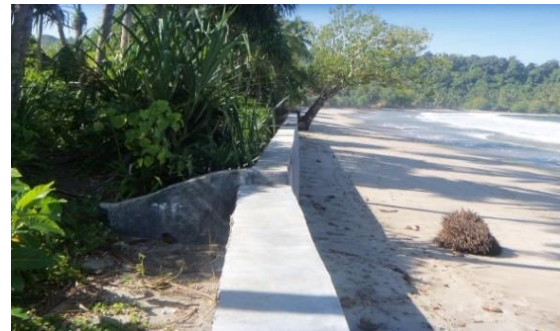
Figure 14. Condition of the coast in 2020 at Balam Village, at first it was a village road

3. The results of this analysis were also proven by asking directly to the elders in the Balam Village area that before 2000 the village road (Fig. 14) was on the talud that was built, whereas currently it is being moved in front towards the land about 50 meters from the talud (Fig. 15).

The local residents also said that from the talud that was visible (Fig. 14) previously there were about 5 rows of coconut trees towards the beach which have now been lost due to abrasion. From the results of the coastline shift analysis, there was a shift from 1989 to 2020 of 42.3 m, if the distance between coconut trees is ± 8 m, then for 5 rows of coconut trees there is a distance of ± 40 m, so the results of

analysis using remote sensing data are not significantly different.

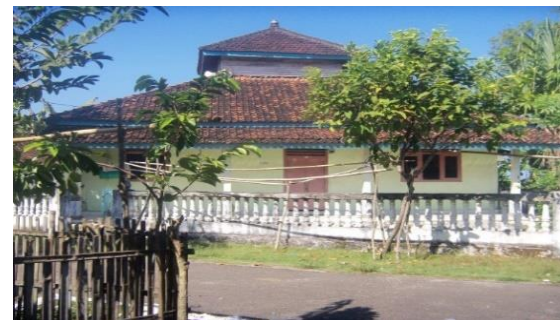
Figure 15. The condition of the village road was moved about 50 m from the beach

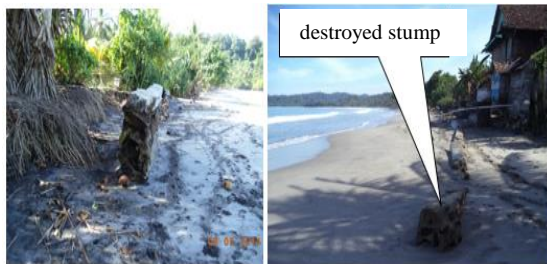
At the end of the village of Balam Village it can also be seen (Fig. 16) that the condition of the ditch installed has been destroyed by coastal abrasion, so it is necessary to find a suitable construction solution to tackle coastal abrasion.

Figure 16. The Beach conditions at the end of Balam village

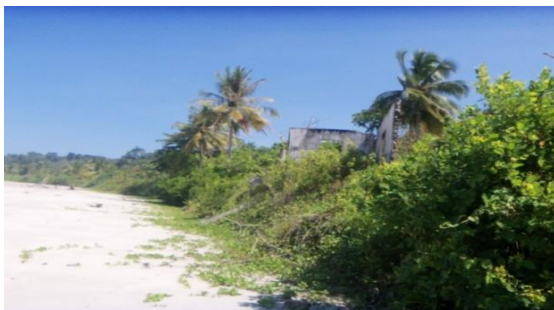
In the Kuripan village area (Fig. 17), it was once a village, but now it no longer exists and has been moved about 2 km from the beach. The results of the analysis used Landsat imagery from 1989 to 2020, there was a shift of 45.3 to 90.3 m.

Figure 17. The condition of the village was lost due to coastal abrasion in the Kuripan village

The results of direct observations in the field show that the condition of the coast is sloping with a stretch of coast in the form of sand and no coast resistance, only in the form of shrubs, this situation allows large abrasion to occur. There needs to be special handling for this kind of area, so that coastal erosion can be controlled.
