Research Article

Evaluation of the Water Quality Status and Pollution Load Carrying Capacity of Way Umpu River, Way Kanan District, Lampung Province, Indonesia, Based on Land Use

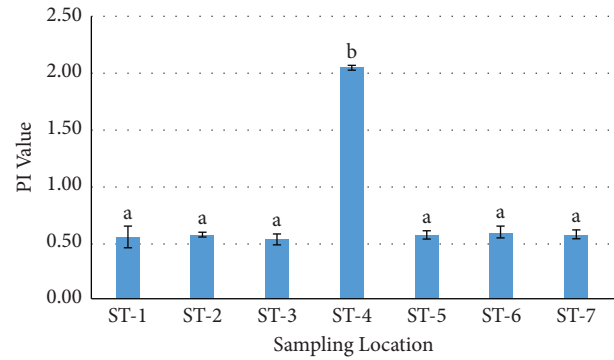
FIGURE 2: Evaluation of river water quality based on PI score.

The results of the physical, chemical, and biological parameter analysis are presented in Table 1 the measurement results for all water quality parameters at all stations were below the quality standard for Class III, except for Station 4, where its TSS, color, and BOD exceed the standard. The estimation result of the water PI score for all stations showed the water quality status was clean and in good condition ($PI < 1$). However, ST-4 showed moderate water polluted quality status ($PI = 2.05$) which exceeded the standard for Class III water use. The PI scores are presented in Figure 2. Based on the results of the analysis of variance (ANOVA) at Station 4 the PI value was significantly different with a p value < 0.05 compared to the other 6 stations (ST-1, ST-2, ST-3, ST-5, ST-6, and ST-7), while between the 6 stations each PI value was not significantly different $p > 0.05$.

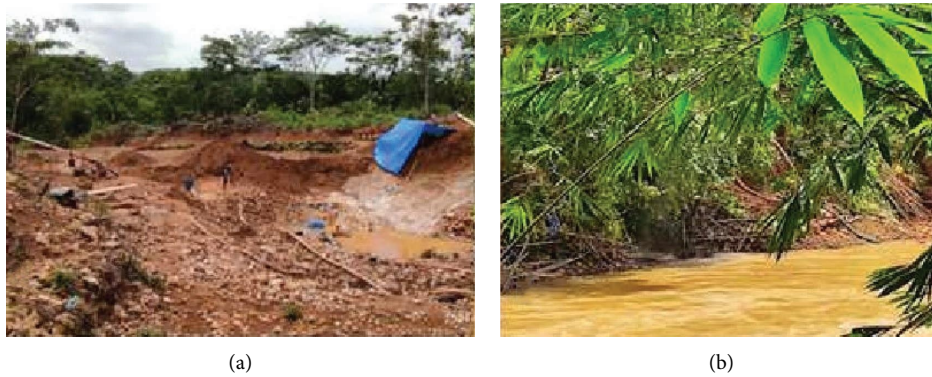
FIGURE 3: (a) Illegal gold mining activity and (b) brown-yellowish water river color after receiving mining waste.

The Ojolali River flow at ST-4 receives waste from illegal gold mining activities that resulted in polluted water conditions, especially in TSS, BOD, and color parameters which are 235 ± 2.8 mg/L, 9.7 ± 0.2 mg/L, and 181 ± 7.1 Pt-Co, respectively. Gold mining is performed by striping soil using a diesel machine-driven soil suction with a big-size hose to suck and dispose of soil in big capacity. Furthermore, this method requires thousands of liters of water and disposes of thousands of cubic of soil daily (Figure 3), which blocks the water flow of rivers surrounding the mining area [24]. Besides that, illegal gold mining affects the quality of the river by turning it into brown-yellowish muddy water. This condition prevents people from relying on the Way Umpu River as a fresh water source, washing, bathing, and fishing, especially during the dry season [14, 15].
